FISH AND FISH HABITAT – EXISTING CONDITIONS AND IMPACT ASSESSMENT REPORT

407 TRANSITWAY

**FROM WEST OF BRANT STREET TO WEST OF HURONTARIO STREET
CITY OF MISSISSAUGA AND CITY OF BRAMPTON (PEEL REGION) AND TOWN
OF HALTON HILLS, TOWN OF MILTON, TOWN OF OAKVILLE AND CITY OF
BURLINGTON (HALTON REGION)**

**APRIL 2020
LGL PROJECT TA #8733**

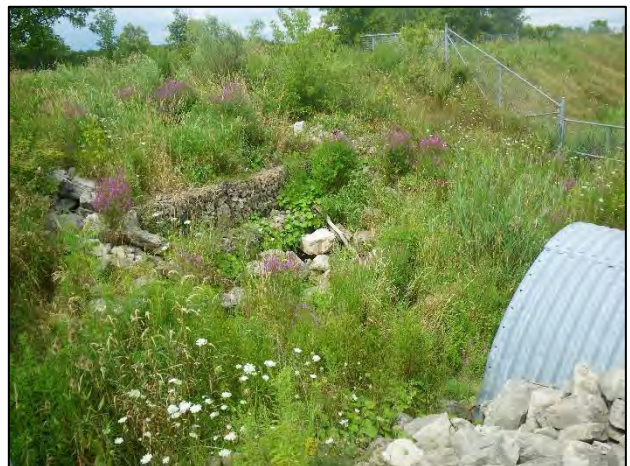
MNRF originally classified this watercourse as warmwater and **low** sensitivity. Based on the results of the field investigation, and the available secondary source information, LGL agrees with the MNRF **low** sensitivity designation. This watercourse constitutes indirect fish habitat from the gabion baskets upstream. Fish (cyprinids) were observed in the pool at the upstream end of the 407 ETR culvert. Therefore, from the gabion basket downstream, this watercourse becomes direct fish habitat.

Site 6: Facing northwest (upstream) at the upstream end of the 407 ETR culvert. Note gabion basket barrier to fish passage (Summer 2019).

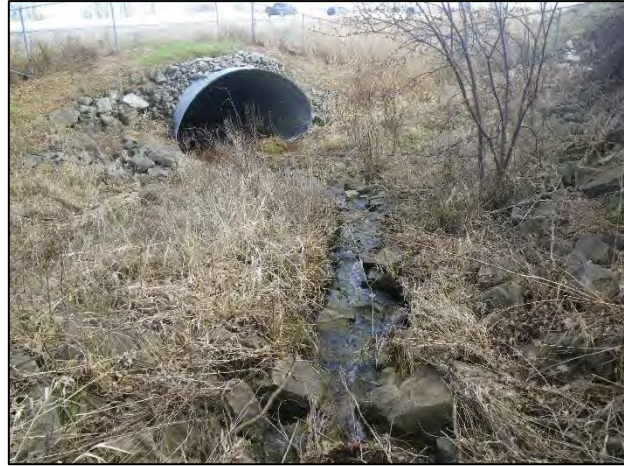
This tributary of Shoreacres Creek is very similar to the watercourse at Site 6: it flows between agricultural fields, drops approximately 2 m upstream of the 407 ETR culvert and contains direct fish habitat. The drop at Site 7 is a rocky ramp comprised of angular stones instead of gabion baskets. As such, it does not comprise a permanent barrier to fish passage as a cyprinid was observed in the channel upstream of it during the spring site visit. Cyprinids were also observed at the upstream end of the culvert both during the spring and summer visits. Like Site 6, water flows intermittently, but a refuge pool exists at the upstream end of the 407 ETR culvert (embedded corrugated steel pipe arch - CSP). Upstream of the rocky ramp, the channel meanders through deciduous trees where there is a lot of bank undercutting, but no evidence of erosion. Further upstream the channel splits where it flows through a meadow marsh between the trees and the agricultural field. Some of the flow goes into the drainage ditch to the west/south of the 407 ETR culvert and some spreads out within the marsh vegetation. A main low flow channel continues upstream, however. Morphology is comprised mainly of runs (65%) with riffles (25%) and pools (10%) making up the remainder. Substrates are generally coarse (boulder, cobble, gravel, sand) at the downstream end near the 407 ETR and finer in the marsh habitat upstream (silt). Channel width ranges from 0.4 m to 1.5 m and depths from 5 cm to 30 cm. Bankfull width is estimated at 2.0 m and bankfull depth at 35 cm to 100 cm.

Site 7: Facing east (downstream) at upstream end of 407 ETR culvert downs rocky ramp (Spring 2019).

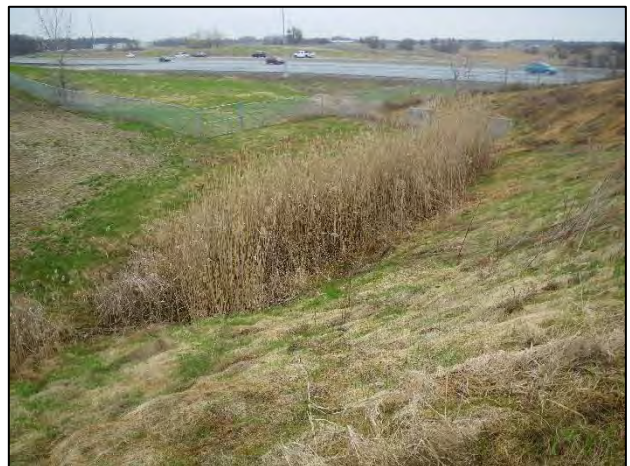
The feature at Site 17 consists of an undefined swale that originates upstream (west) of Tremaine Road that passes through a small diameter CSP culvert and enters the ditch at the bottom of the Tremaine Road slope. From there, water is conveyed southward through this *Phragmites*-lined ditch and into a CSP culvert that passes under the 407 ETR. There is a high gradient within the CSP culvert, the culvert is not countersunk and there is evidence of corrosion along its bottom. A small amount of flow was observed during the spring site visit and the feature was dry during the summer.

Site 17: Facing east (downstream) from downstream end of the Tremaine Road crossing at the short channel upstream of the 407 ETR culvert (Spring 2019).

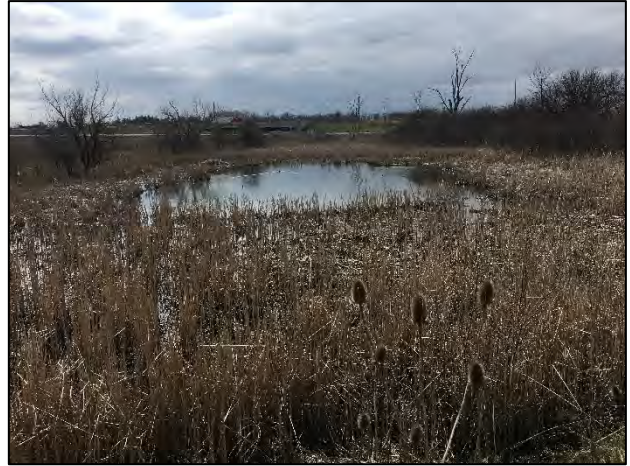
The watercourse at Site 24 is permanently flowing with a well-defined channel that is conveyed under the 407 ETR through four lined (with smooth black plastic) CSP culverts. Water was flowing during both the spring and summer site visits and fish were observed. Flow is conveyed through all four culverts and, as a result, the channel is very wide at this location. At the downstream end of the culverts, the channel is lined with rip rap and there is dense growth of cattails and some *Phragmites*. The channel quickly narrows and flows in a straight line for 40 m to 50 m. In this section wetted width is fairly wide (2 m) and shallow (10 cm) and is lined with cattails. The banks are grassy and there is an area of rip rap that appears to be used as a ford for vehicles. From the end of this section, the channel narrows further (1 m wide, 10 cm deep) as it enters an area with more natural vegetation (cattails and dense grasses) which extends for another 30 m. There it enters a cattail marsh with a large open water pond. The pond is approximately 38 m long and 18 m wide and is ringed with cattails. From the pond, the channel reforms and meanders away from the 407 ETR in a relatively narrow (1.5 m wide), incised channel approximately 20 cm deep. With the exception of the pond, almost the entire channel is comprised of run habitat with very few riffles. Instream cover is mainly provided by emergent vegetation. Recent restoration (plantings and fencing) is evident along the channel downstream of the pond and around the pond itself.

Site 24: Facing west (upstream) at the online pond just downstream of the preferred runningway (Spring 2019).

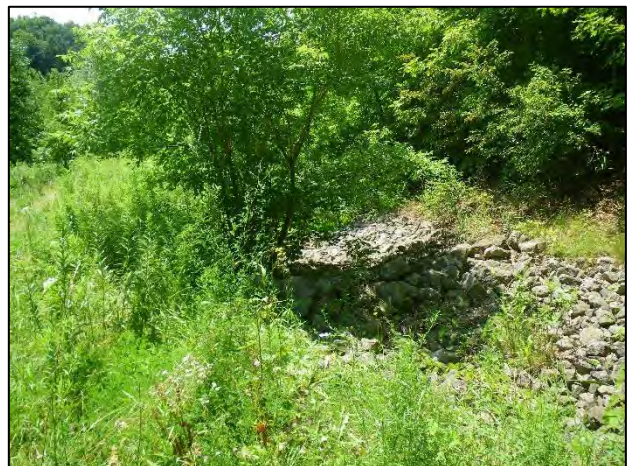
Site 30: Facing south (downstream) at rip rap slope further downhill (Summer 2019).

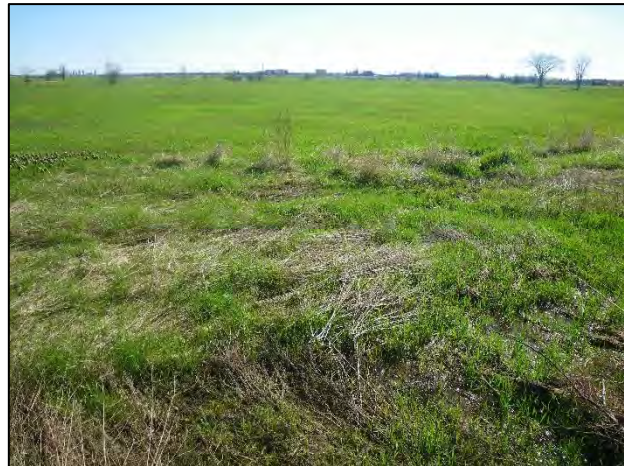
Site 38: Facing northeast (downstream) from the station location. Flow spreads out in hay field (Spring 2019).

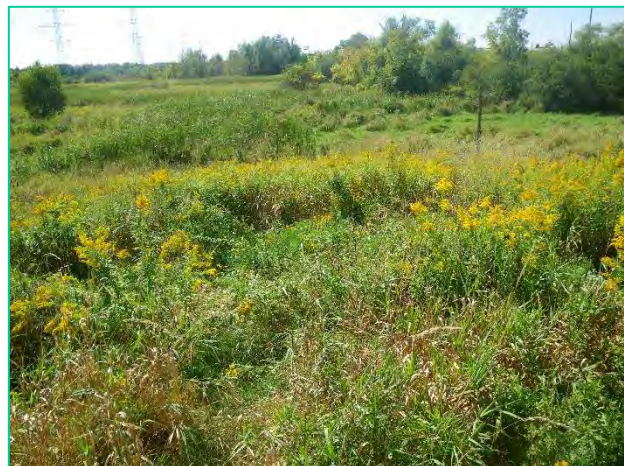
Site 52-54: Facing southwest (downstream) where the watercourse spreads out in a large meadow marsh downstream of the 407 ETR crossing (Summer 2019).
