407 TRANSITWAY – WEST OF HURONTARIO STREET TO EAST OF HIGHWAY 400

MINISTRY OF TRANSPORTATION - CENTRAL REGION

**STAGE 2 ARCHAEOLOGICAL ASSESSMENT
407 TRANSITWAY FROM WEST OF HURONTARIO STREET TO EAST OF HIGHWAY 400**

26 July 2018

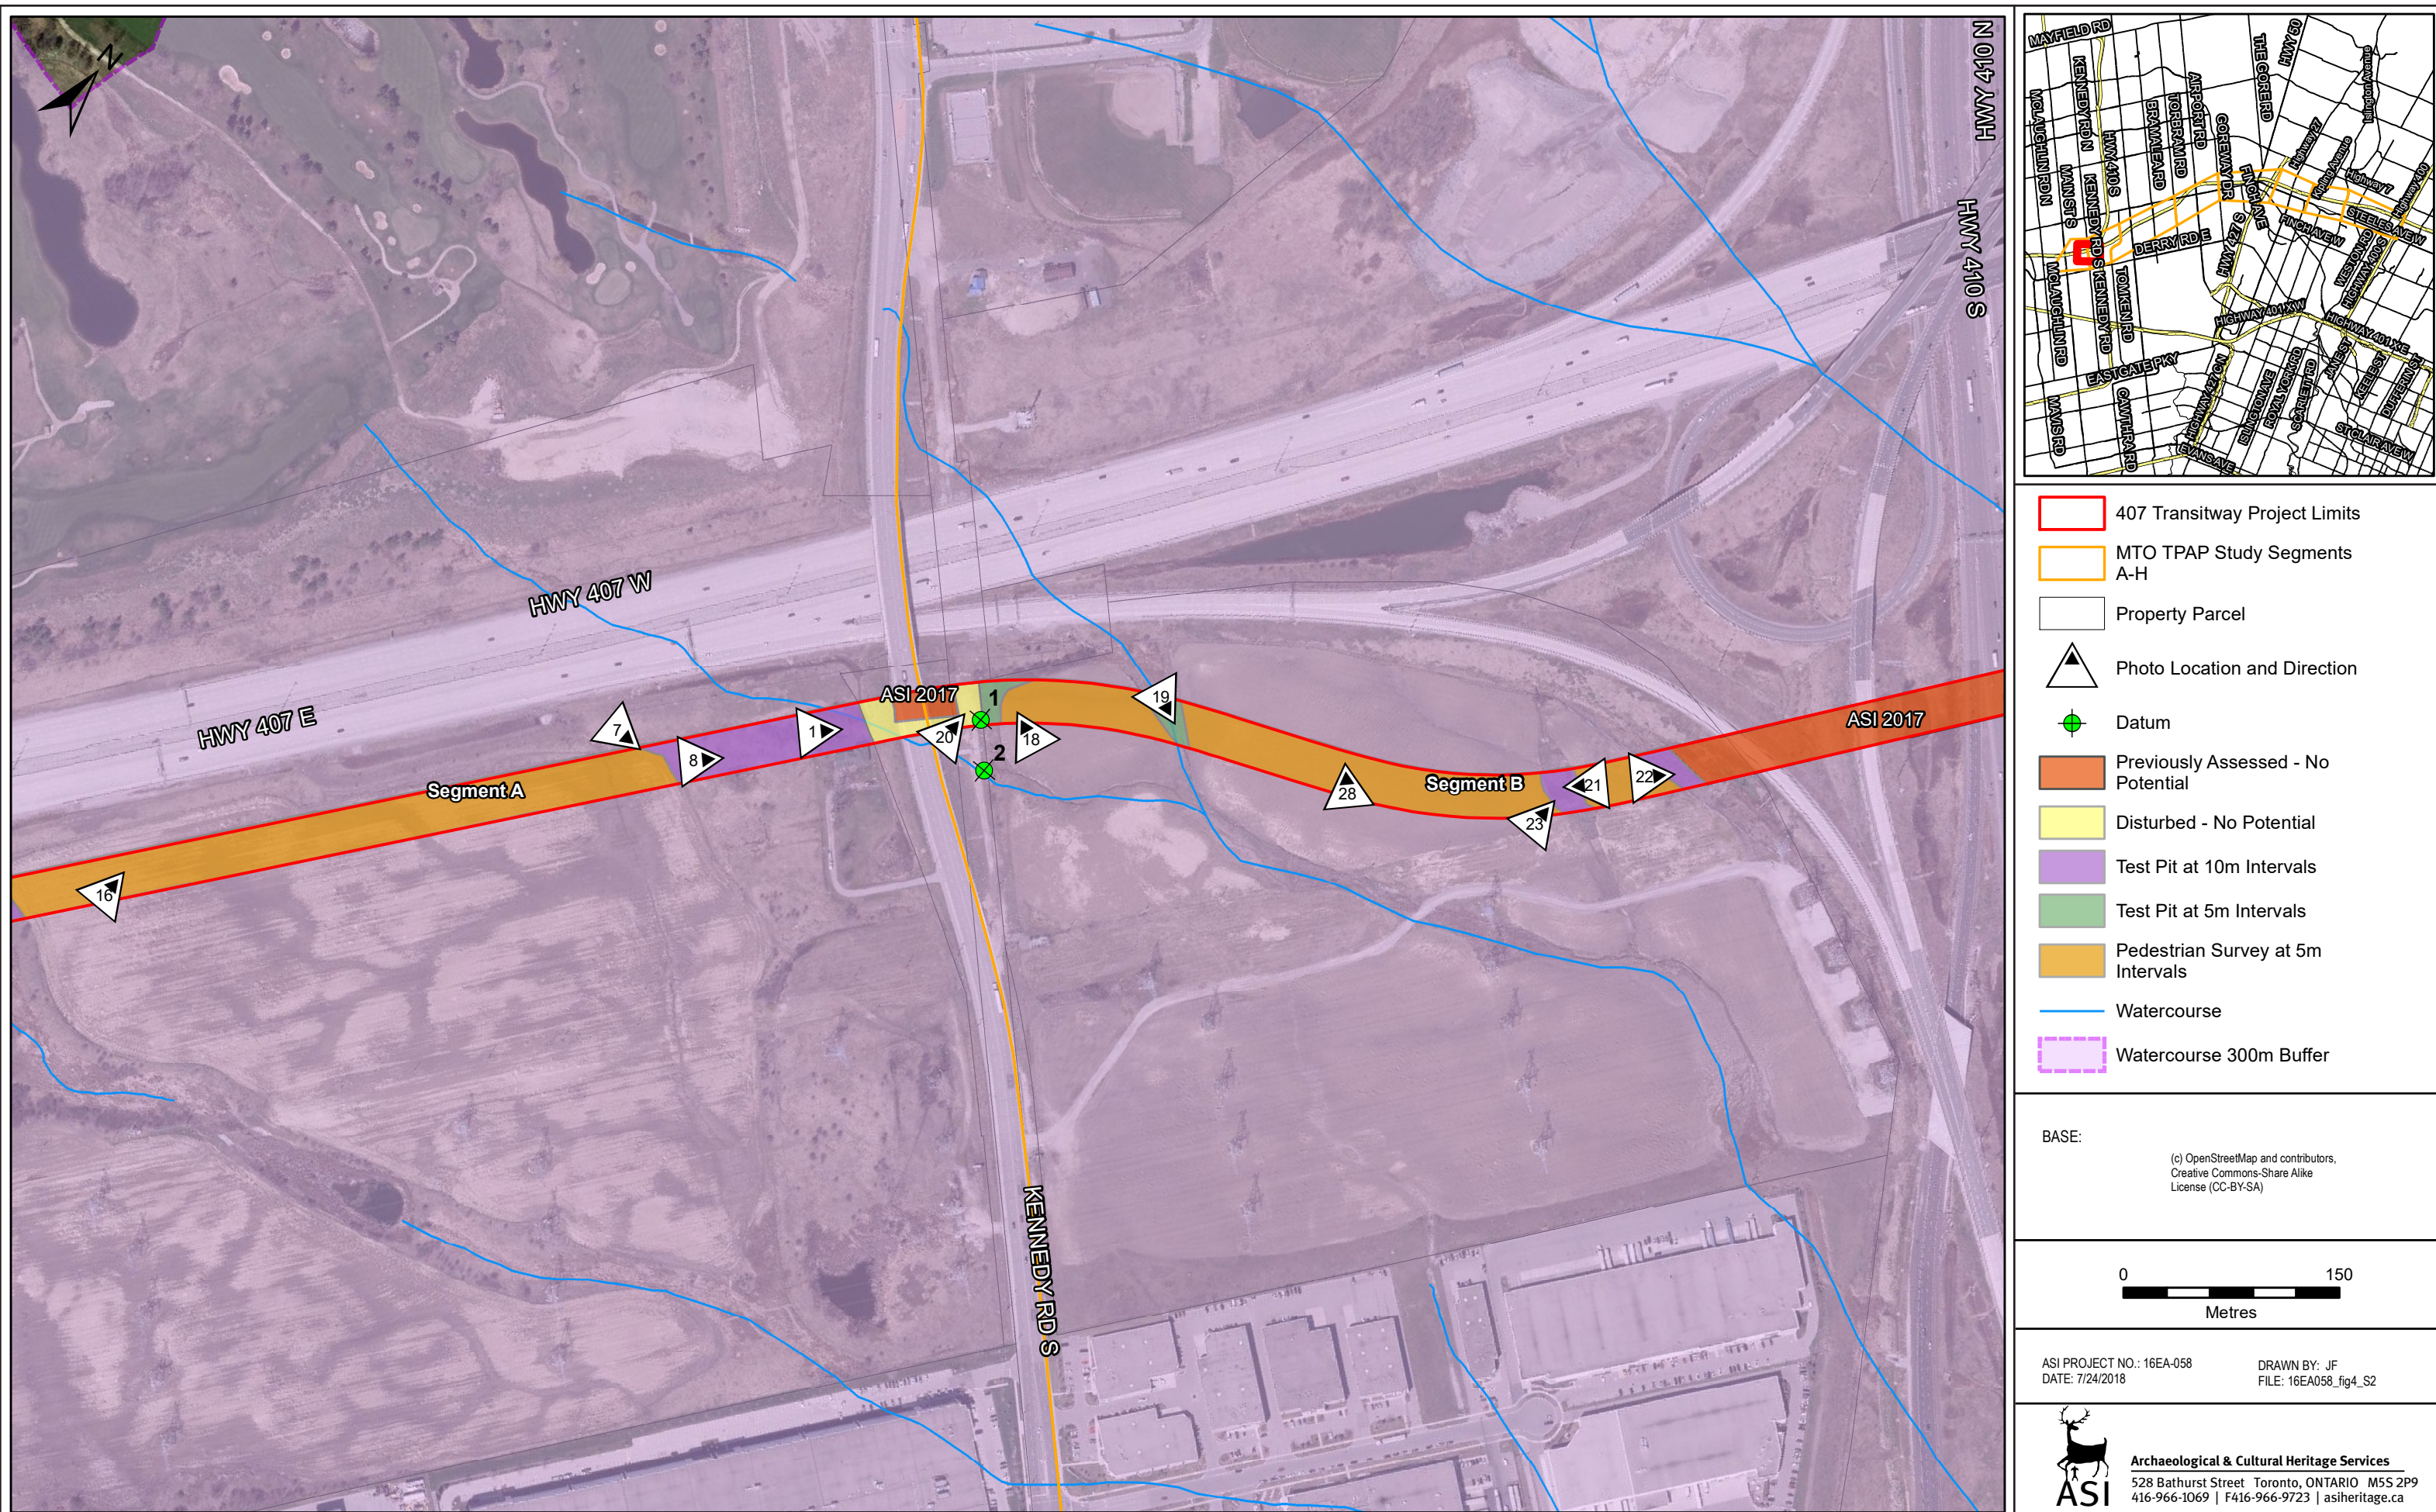
Figure 4: Stage 2 Assessment Results for the 407 Transitway Project (Sheet 2)

Segment B of the 407 Transitway Project extends from its western boundary at Kennedy Road to its eastern boundary at Tomken Road, in the City of Brampton. The results of the Stage 1 assessment (ASI 2017) determined that 48.8 % of Segment B did not retain archaeological potential due to previous archaeological assessment and was not subject to Stage 2 survey (Figures 4-6; Table 5). In addition, 1.9 % (0.14 ha) of Segment B was found to have no archaeological potential during the assessment due to previous deep and extensive ground disturbance and was therefore not subject to Stage 2 survey (Figures 4-5). Areas of previous disturbance resulting in the removal of archaeological potential include the Kennedy Road ROW and a portion of the commercial property on Farmhouse Court (Figures 4-6; Plates 1 and 17).

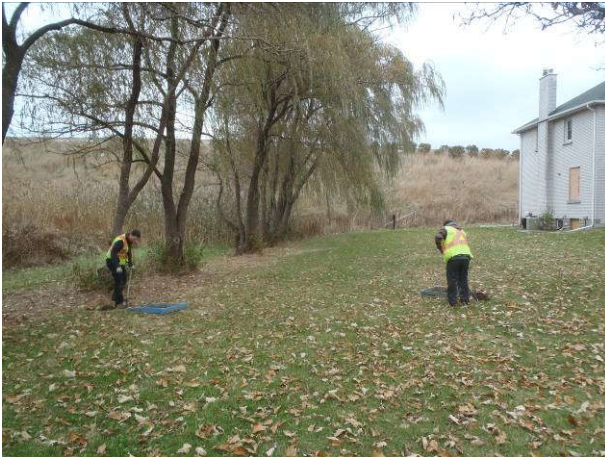
Plate 1 [NE]: Foreground: judgmental test pit survey (10 m); background: previously disturbed raised ROW of Kennedy Road, no potential

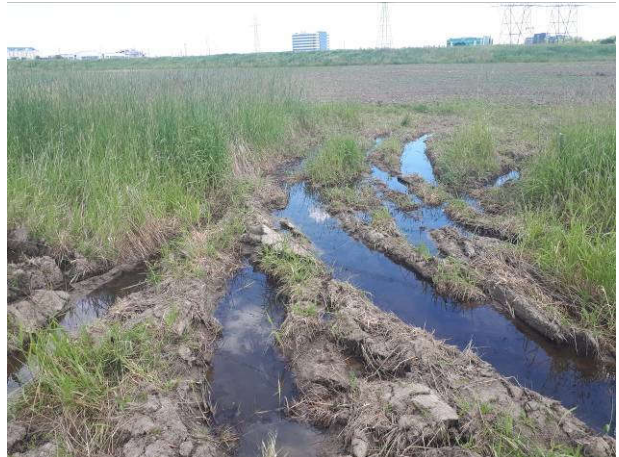
Plate 2 [SE]: Foreground: permanently low and wet tributary of Fletcher's Creek; midground: area subject to pedestrian survey at 5 m intervals; background: previously disturbed Hydro One access road, no potential

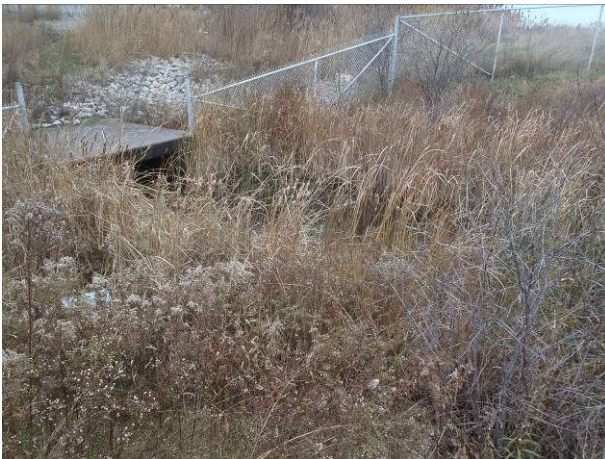
Plate 3 [N]: Culvert for Etobicoke Creek West tributary; permanently low and wet, no potential

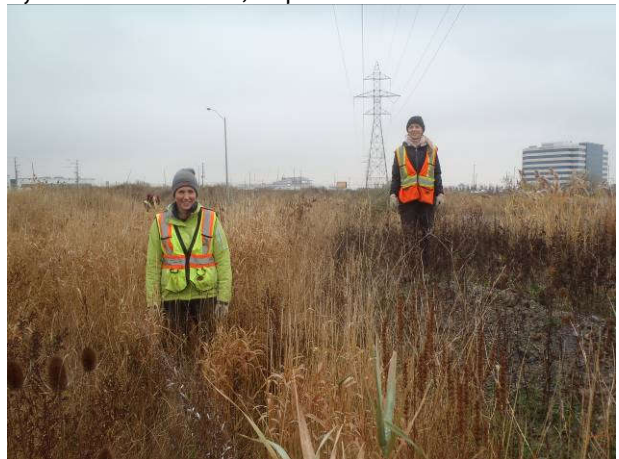
Plate 4 [NE]: Sloped banks of Etobicoke Creek West tributary; no potential

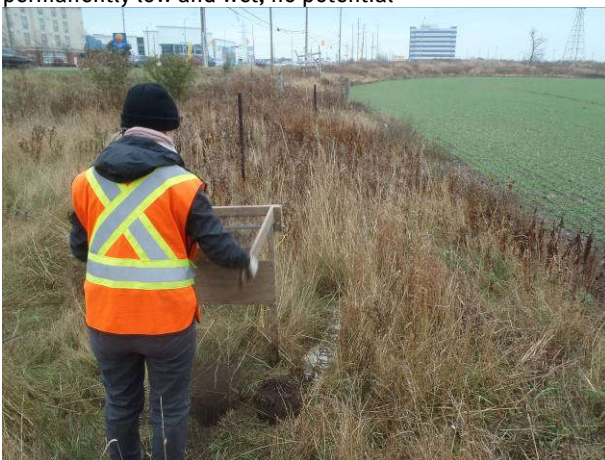
Plate 5 [SE]: Foreground: judgmental test pit survey (10 m) adjacent to Hurontario Street ROW; no potential

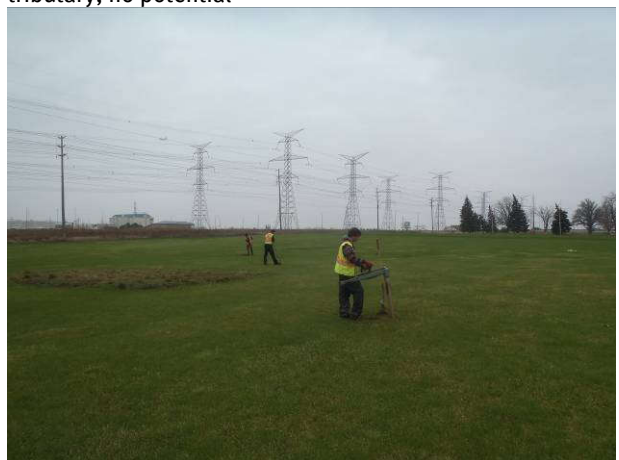
Plate 6 [S]: Judgmental test pit survey (10 m) of driving range; no potential

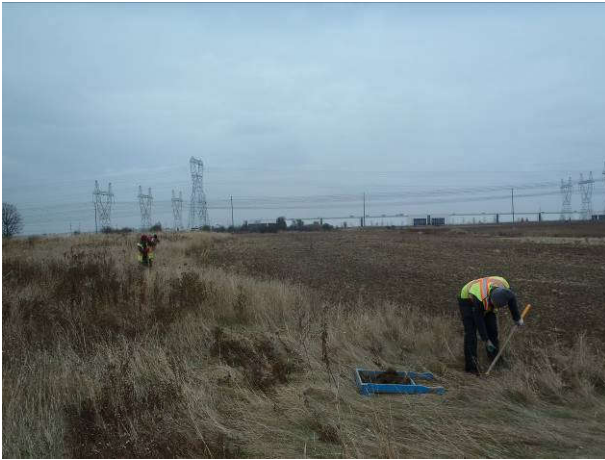
Plate 7 [E]: Judgmental test pit survey (10 m) intervals in fallow scrubland adjacent to field; no potential

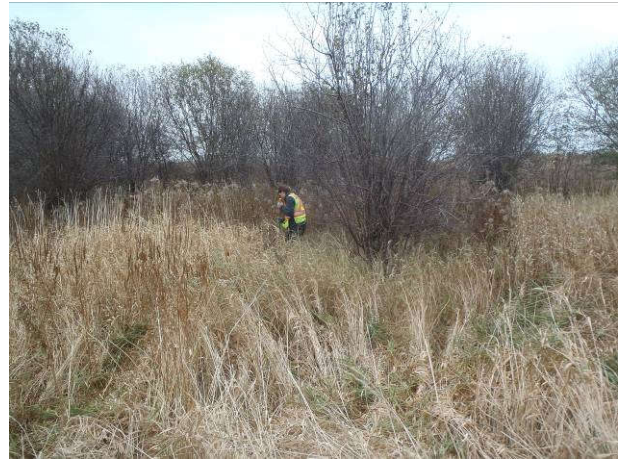
Plate 8 [NE]: Judgmental test pit survey (10 m) in fallow scrubland; no potential

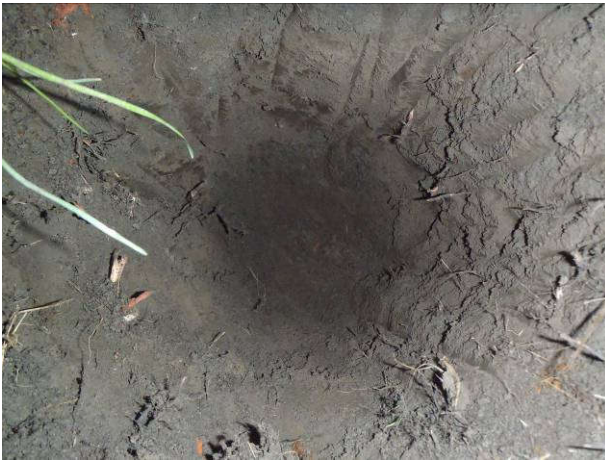
Plate 9 [N]: Disturbed stratigraphy encountered by Hydro One access road ROW; no potential

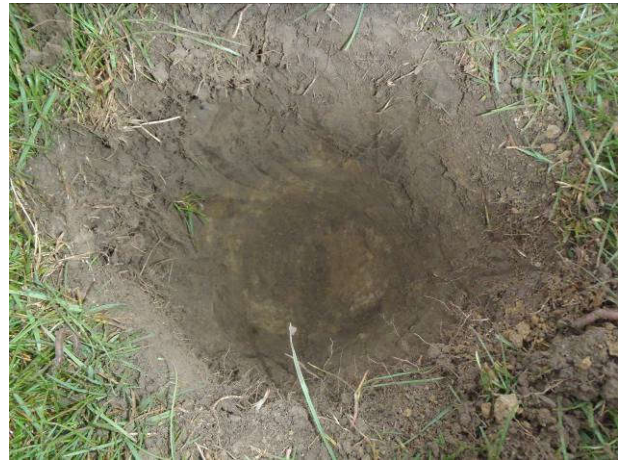
Plate 10 [N]: Stratigraphy representative of disturbed soil profiles encountered in driving range, fallow scrubland, and vacant residential property; no potential

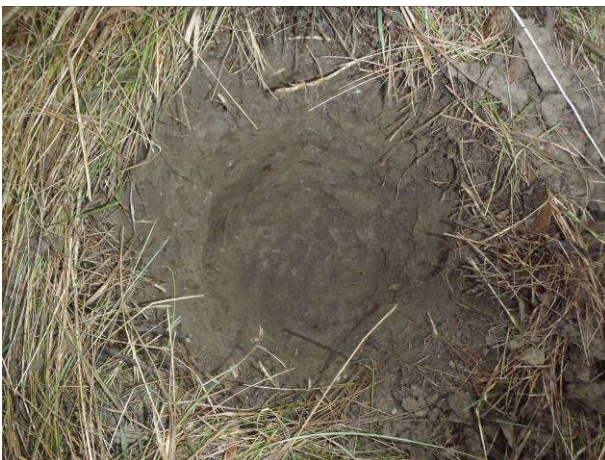
Plate 11 [N]: Disturbed soil encountered within the channelized floodplain of Etobicoke Creek West tributary

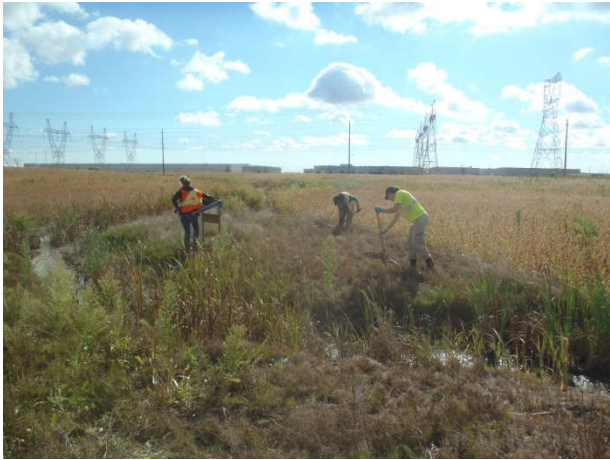
Plate 19 [ESE]: Undisturbed stratigraphy encountered during test pit survey (5 m) east of Kennedy Road ROW next to agricultural field

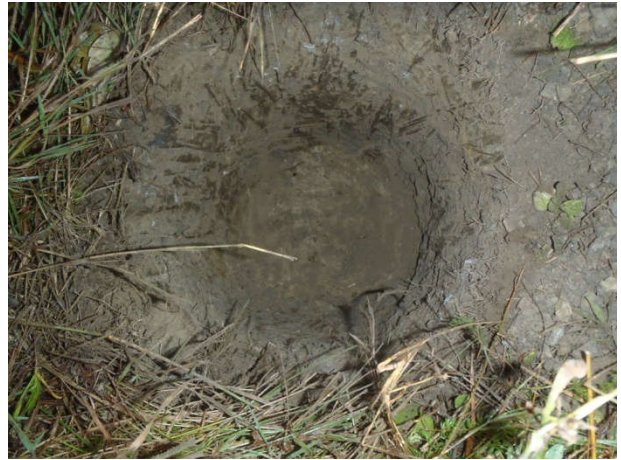
Plate 20 [N]: Undisturbed stratigraphy encountered during test pit survey (5 m) adjacent to tributary of Etobicoke Creek West

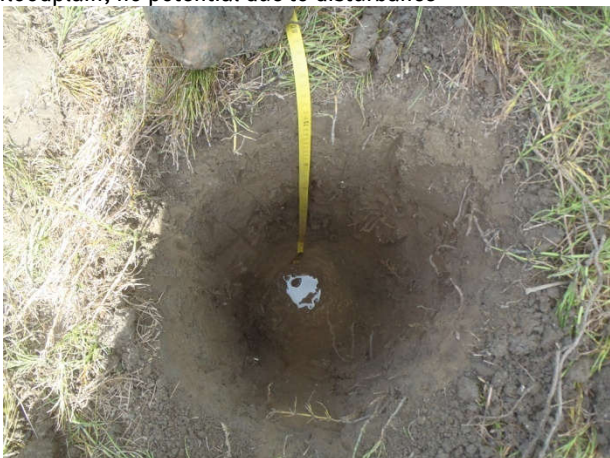
Plate 23 [N]: Disturbed stratigraphy representative of scrubland within floodplain adjacent to HWY 407/HWY 410 interchange; no potential

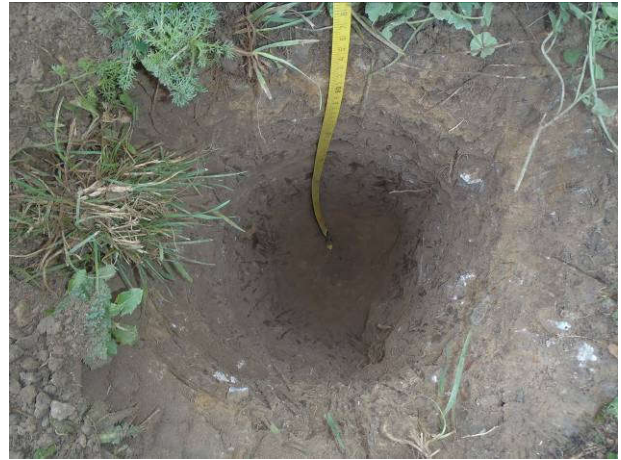
Plate 26 [N]: Disturbed stratigraphy representative of the soils encountered east and west of Farmhouse Court

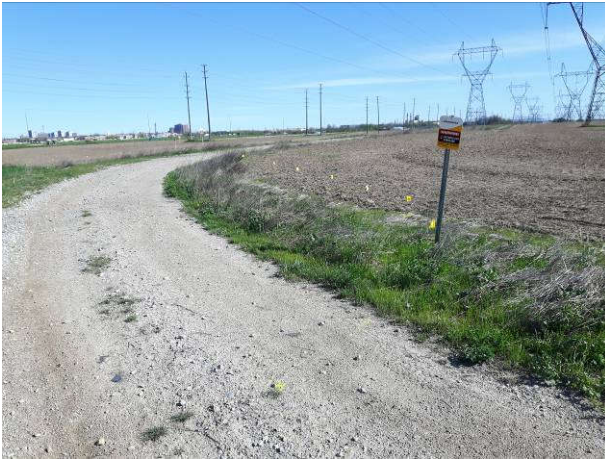
Plate 31 [NW]: Hydro One gravel access road and Enbridge gas line subject to previous disturbance; no potential

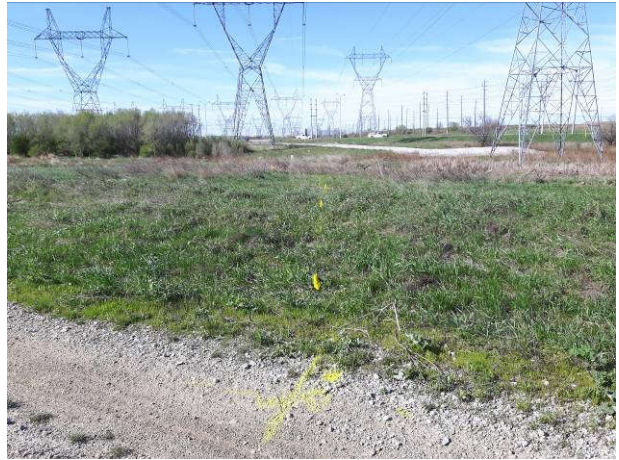
Plate 32 [SW]: Enbridge gas line subject to previous disturbance; no potential

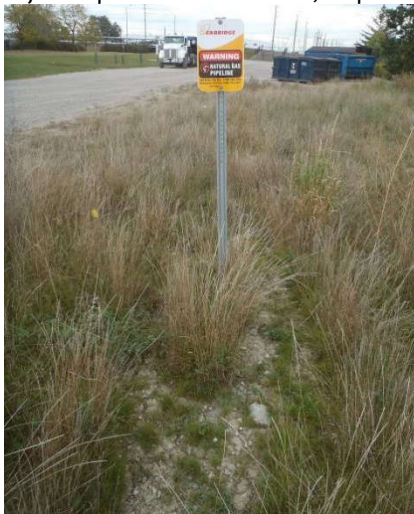
Plate 33 [NNE]: Previously disturbed Hydro One gravel access road and area surrounding Enbridge gas line subject to judgmental test pit survey (10 m); no potential

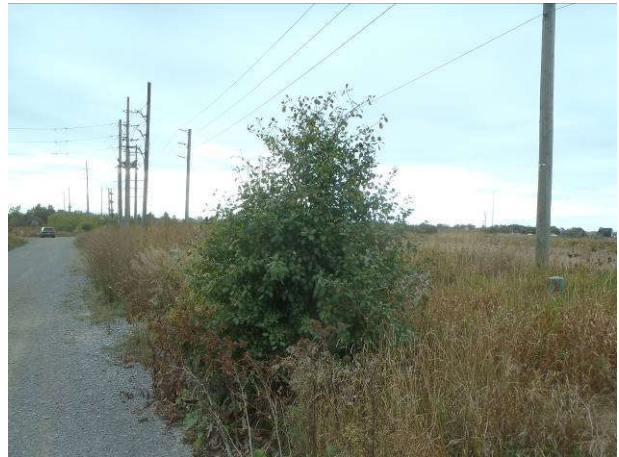
Plate 34 [SW]: Previously disturbed Hydro One gravel access road and area subject to judgmental test pit survey (10 m); no potential

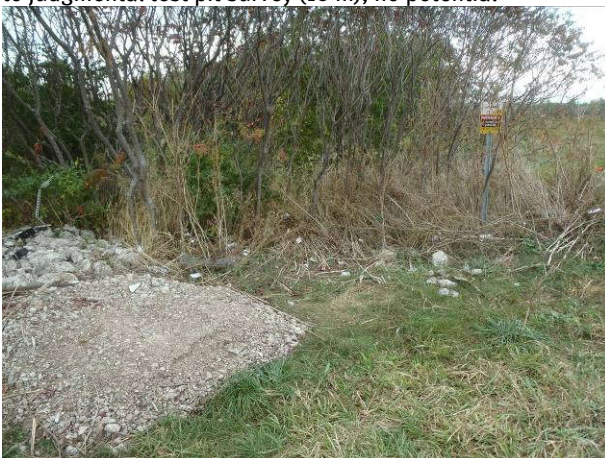
Plate 35 [ESE]: Previously disturbed Enbridge gas line, surrounding area subject to judgmental test pit survey (10 m); no potential

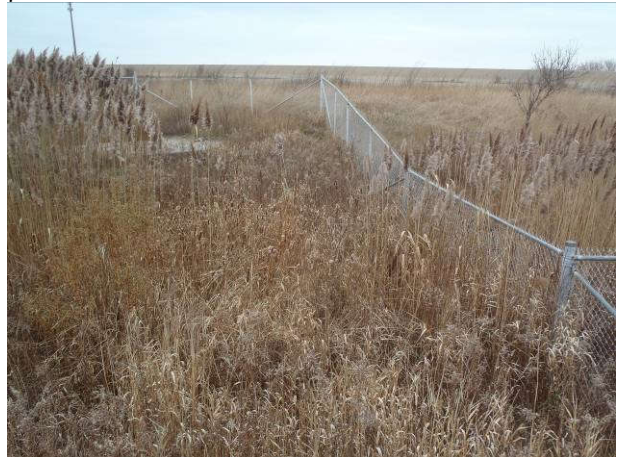
Plate 40 [SW]: Drainage culvert and permanently low and wet area visible by tall water grasses; no potential

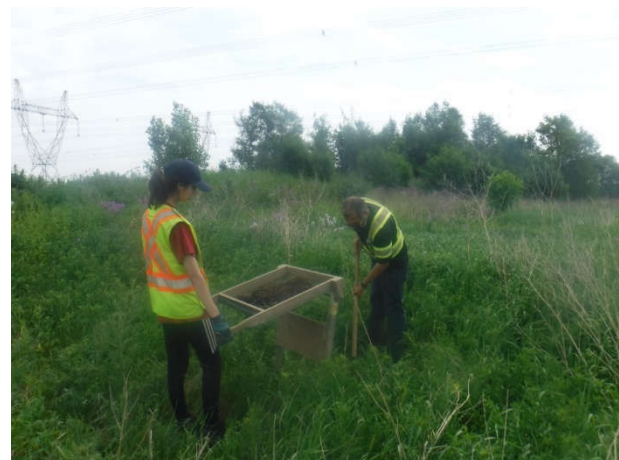
Plate 41 [NE]: Permanently low and wet area of a Mimico Creek tributary; no potential

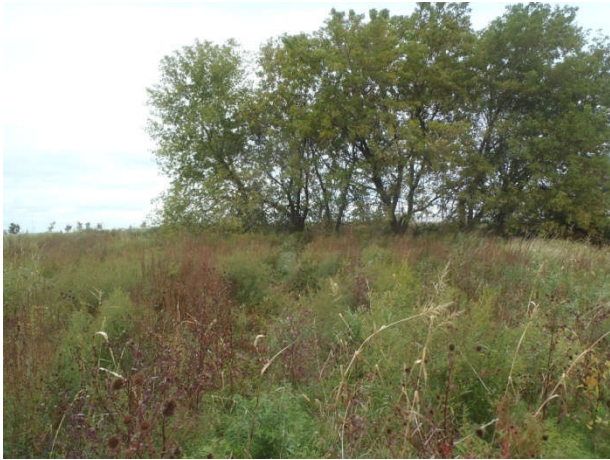
Plate 42 [SW]: Test pit survey at 5 m intervals

The remainder of Segment C was assessed as having archaeological potential and was subject to Stage 2 test pit survey and pedestrian survey. Test pit survey at five metre intervals was conducted on scrubland located just east of Dixie Road (Figure 6; Plates 42 and 50; Table 7). Disturbed soils were encountered and assessed by judgmental test pit survey at 10 m intervals on scrubland located just east of Dixie Road (Plate 43), either side of Bramalea Road (Plates 44-45), and the scrubland located between the agricultural fields adjacent to the 407 ETR ROW west of Torbram Road (Figures 6-8; Plate 46; Tables 6 and 7). The lands immediately adjacent to the 407 ETR ROW were likely disturbed during the construction of the highway.

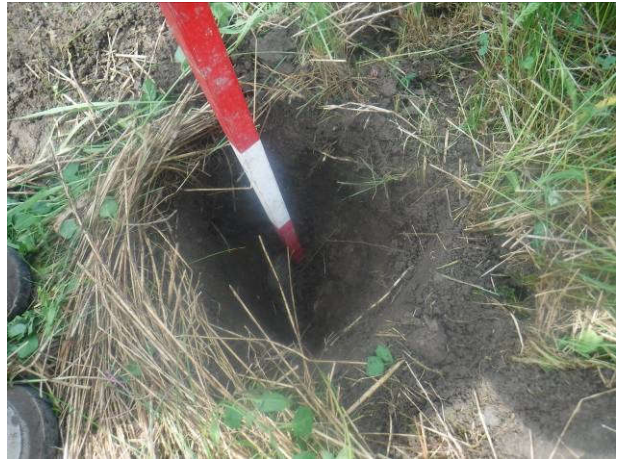
Plate 50 [N]: Undisturbed soils encountered east of Dixie Road during test pit survey at 5 m intervals

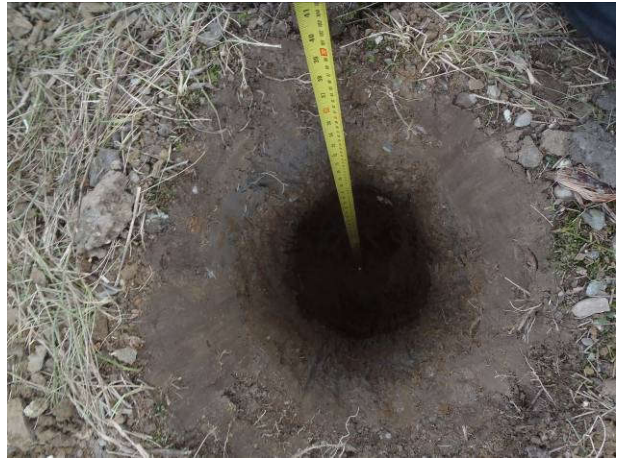
Plate 52 [N]: Disturbed stratigraphy representative of the soils encountered between Dixie Road and Torbram Road during judgmental test pit survey at 10 m intervals

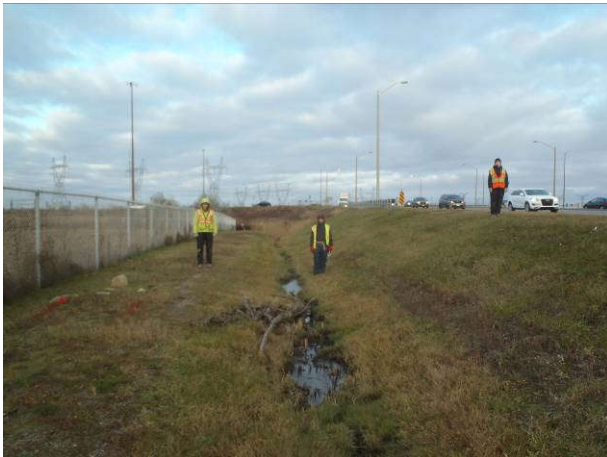
Plate 56 [SW]: Previously disturbed landscaped 407 ETR berm terminating at permanent wetland; no potential

Segment D of the 407 Transitway Project extends from its western boundary at Torbram Road to its eastern boundary at Goreway Drive, in the City of Brampton. The results of the Stage 1 assessment (ASI 2017) determined that 34.4 % of Segment D did not retain archaeological potential due to previous archaeological assessment and was not subject to Stage 2 survey (Figures 9-11; Table 8). In addition, 3.3 % (0.71 ha) of Segment D was found to have no archaeological potential during the Stage 2 assessment due to previous deep and extensive ground disturbance, severe slope (>20°), and permanently low and wet conditions and was therefore not subject to Stage 2 survey (Figures 10-11; Table 8). Lands subject to previous deep and extensive ground disturbance resulting in the removal of archaeological potential include the raised CN rail corridor and the Goreway Drive ROW (Figure 10-11; Plates 53-57). Severe slope resulting in the removal of archaeological potential was documented adjacent to Mimico Creek running through the Project Limits east of the CN rail corridor and west of Goreway Drive (Plate 58). Lastly, areas documented as permanently low and wet include Mimico Creek and smaller tributaries of Mimico Creek running through the Project Limits east and west of the CN rail corridor (Plates 56, 59-60).

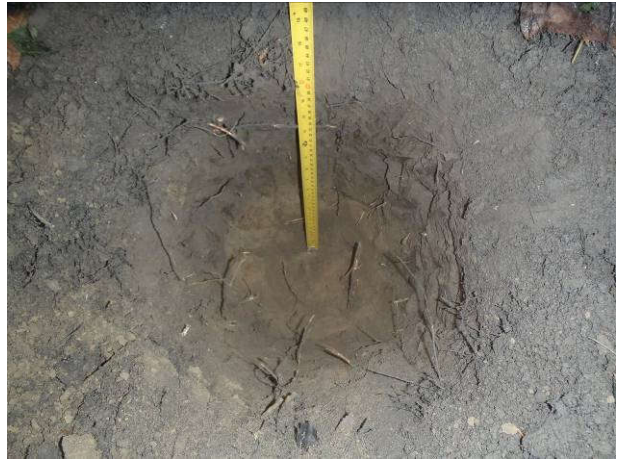
Plate 62 [N]: Undisturbed stratigraphy representative of the woodlot east of CN rail corridor

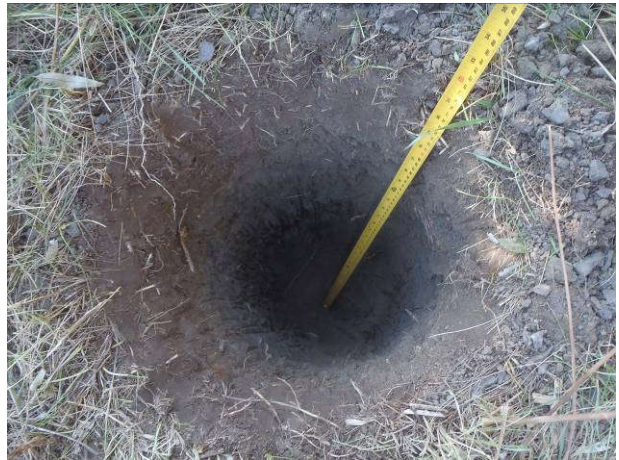
Plate 64 [N]: Disturbed stratigraphy representative of the scrubland west of CN rail corridor outside of wetlands

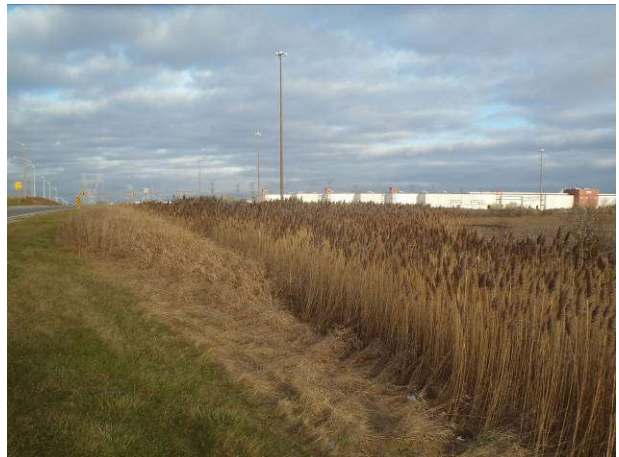
Plate 65 [NE]: Pedestrian survey at 5 m intervals

The balance of Segment D demonstrating archaeological potential was subject to pedestrian survey at five metre intervals and reduced to one metre intervals when artifacts were encountered (Figures 9-10; Plate 65; Table 8). Soils of the agricultural field consist of clay-loam ploughzone. During the course of the Stage 2 survey within Segment D three pre-contact Indigenous findspots (P2, P5, and P6) and two pre-contact Indigenous sites (P3/AkGv-349 and P4/AkGv-350) were encountered (SD: Figure 2). Of the two sites identified, Site P4 (AkGv-350) requires Stage 3 assessment (see Section 4.0 for details).

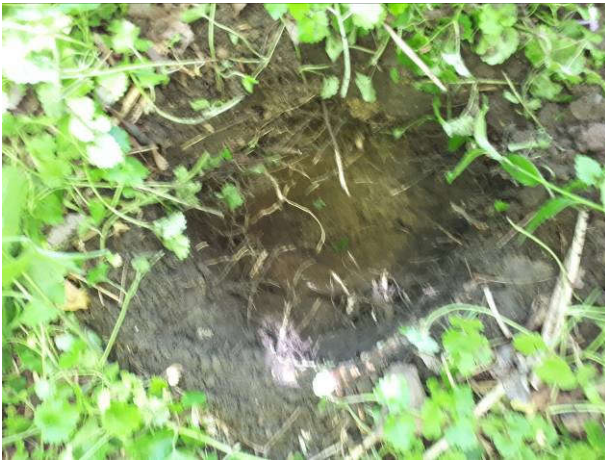
Plate 68 [N]: Test pit survey at 5 m intervals in undisturbed woodlot

The remainder of Segment E was assessed as having archaeological potential and was subject to Stage 2 test pit survey and pedestrian survey. Test pit survey at five metre intervals was conducted on the woodlot immediately west of Gorewood Drive/Finch Avenue West (Figure 12; Plate 68; Table 9). Soils within the woodlot were undisturbed and composed of 30 cm of dark yellowish-brown (10YR 4/4) sandy-loam topsoil overlying a yellow (10YR 7/8) sand subsoil (Plate 69). Disturbed soils were encountered within the scrubland immediately west of Gorewood Drive/Finch Avenue West and assessed by judgmental test pit survey at 10 m intervals (Figure 12; Plates 70; Table 9). The stratigraphy encountered in these locations is composed of approximately 50 cm of compact white (10YR 8/1) clay containing coarse gravel overlying a brownish-yellow (10YR 6/6) silty-sand subsoil (Plate 71).

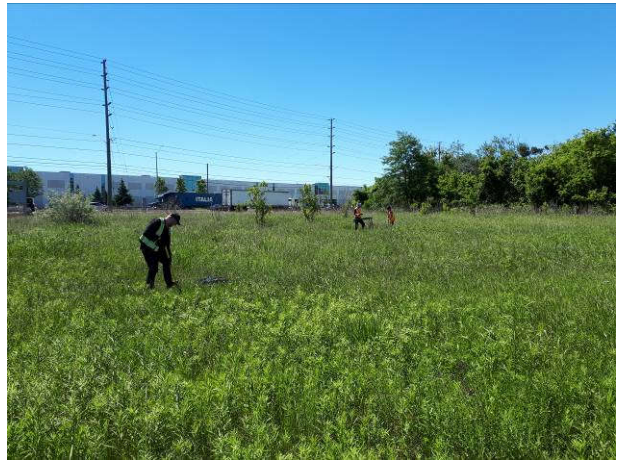
Plate 70 [S]: Judgmental test pit survey (10 m) in scrubland; no potential due to previous disturbance

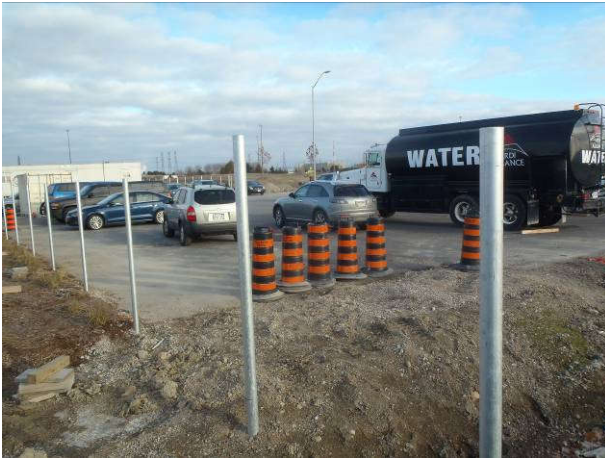
Plate 72 [WSW]: Pedestrian survey at 5 m intervals

The balance of Segment E demonstrating archaeological potential was subject to pedestrian survey at five metre intervals (Figure 11; Plate 72; Table 9). Soils encountered within the agricultural field consist of clay-loam ploughzone containing coarse gravel. It is likely that the agricultural fields that lie within Segment E of the Project Limits have been disturbed during the construction of the 407 ETR corridor.

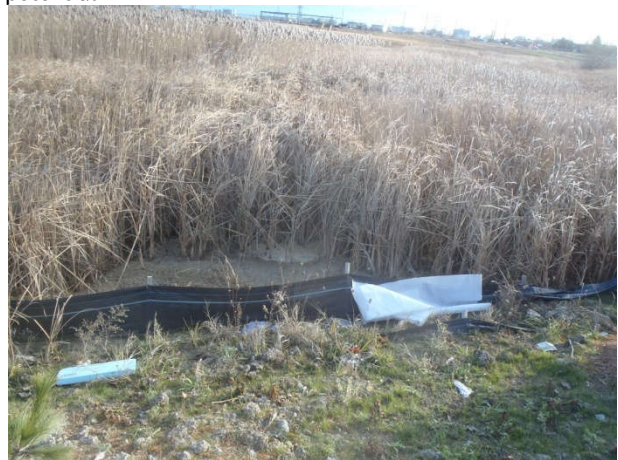
Plate 75 [NW]: Newly installed drainage culvert as part of 407 ETR Concession Company Ltd.; no potential

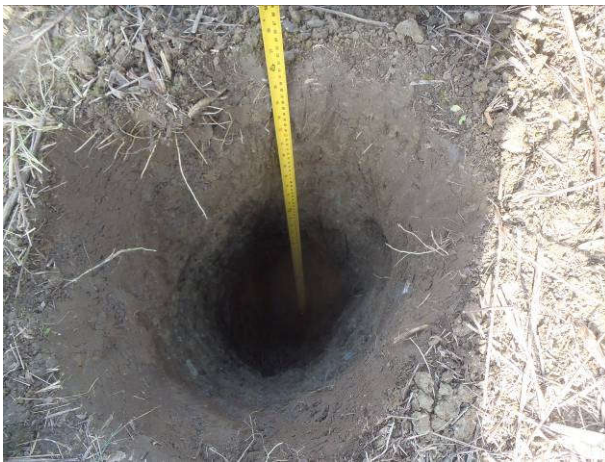
Plate 80 [ENE]: Judgmental test pit survey at 10 m intervals to confirm previous disturbance of HWY 407 ETR berm; no potential

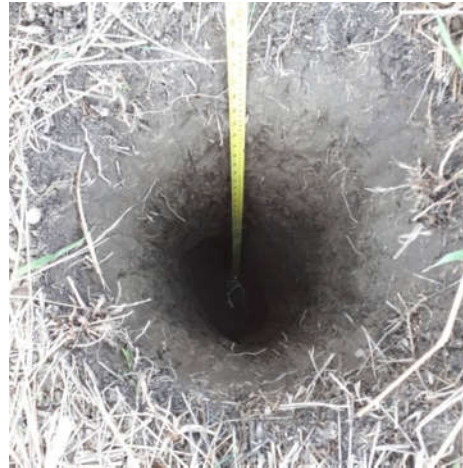
Plate 81 [N]: Disturbed stratigraphy encountered during judgmental test pit survey at 10 m intervals of farm; no potential

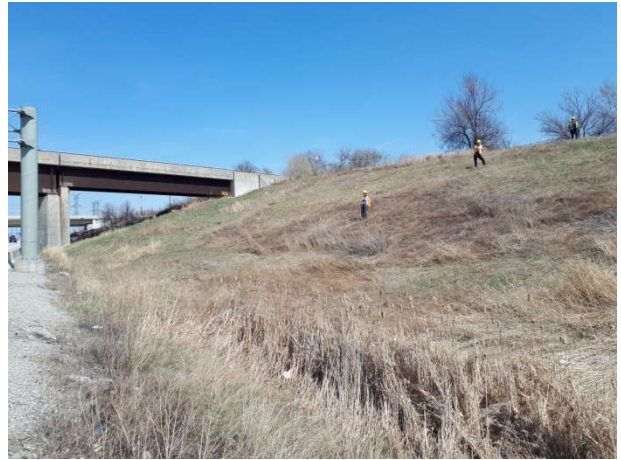
Plate 91 [SW]: Previously disturbed landscaped berm and ditch within the HWY 407 ETR corridor; no potential

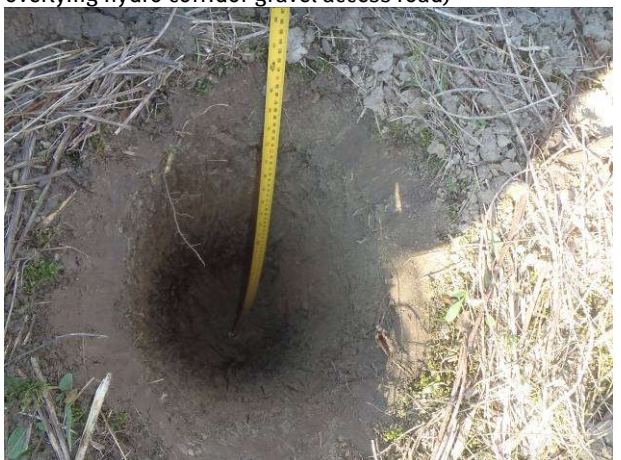
Plate 96 [N]: Disturbed stratigraphy encountered during judgmental test pit survey; no potential

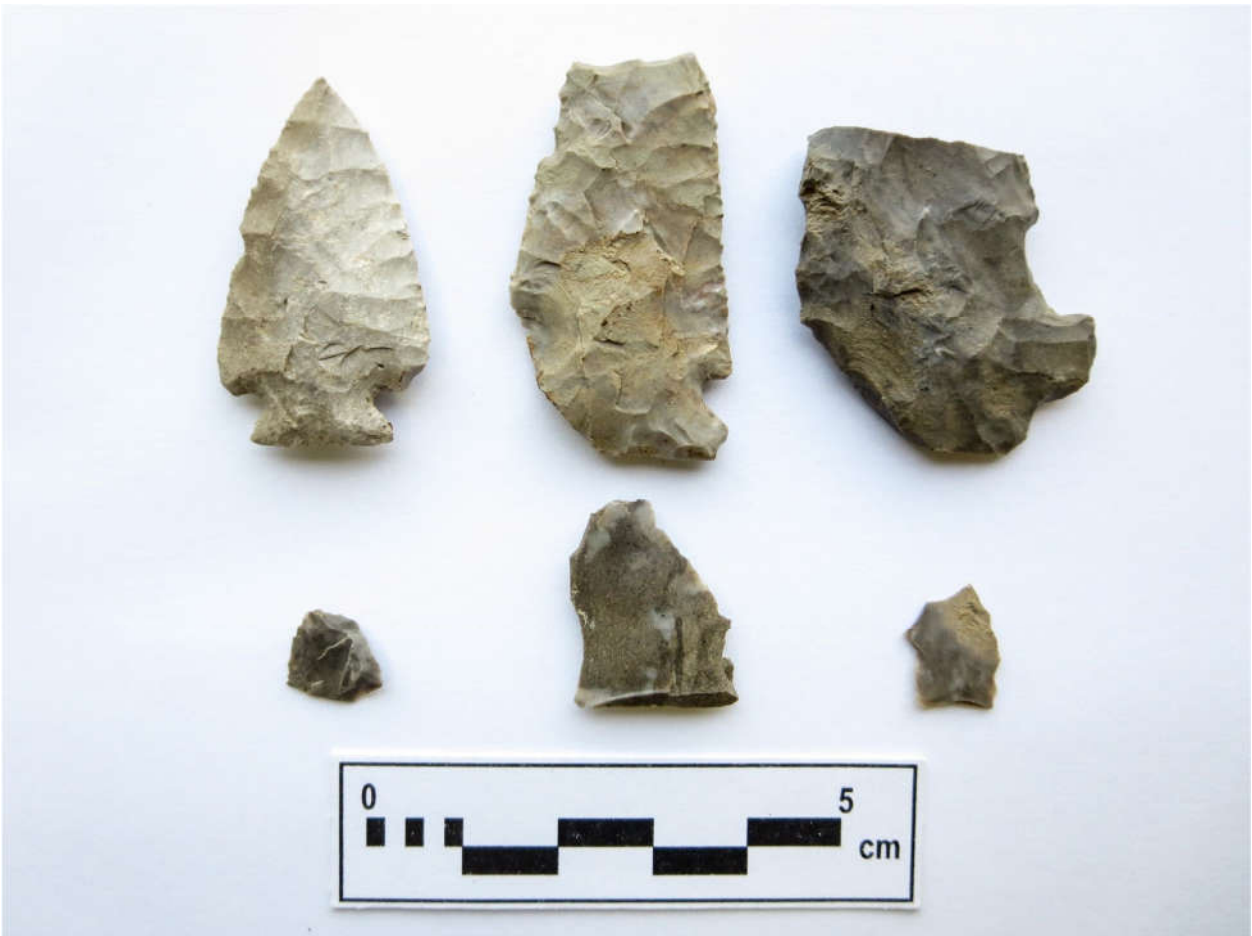
Plate 98: Select artifacts recovered during Stage 2 survey from left to right, top to bottom: Early Archaic Nettling projectile point (Site P4, Cat. #L1), Early Archaic Nettling projectile point (Site P4, Cat. #L2), non-diagnostic biface fragment (Site P6, Cat. #L1), a secondary retouch flake (Site P5, Cat. #L1), a secondary knapping flake (Site P2, Cat. #L1), and a flake fragment (Site P3, Cat. #L3).
