Appendix F: Heritage Impact Assessment Report

407 TRANSITWAY - KENNEDY ROAD TO BROCK ROAD

HERITAGE IMPACT ASSESSMENT:

**8119 REESOR ROAD, CITY OF MARKHAM, AND
8042 REESOR ROAD, CITY OF MARKHAM
REGIONAL MUNICIPALITY OF YORK**

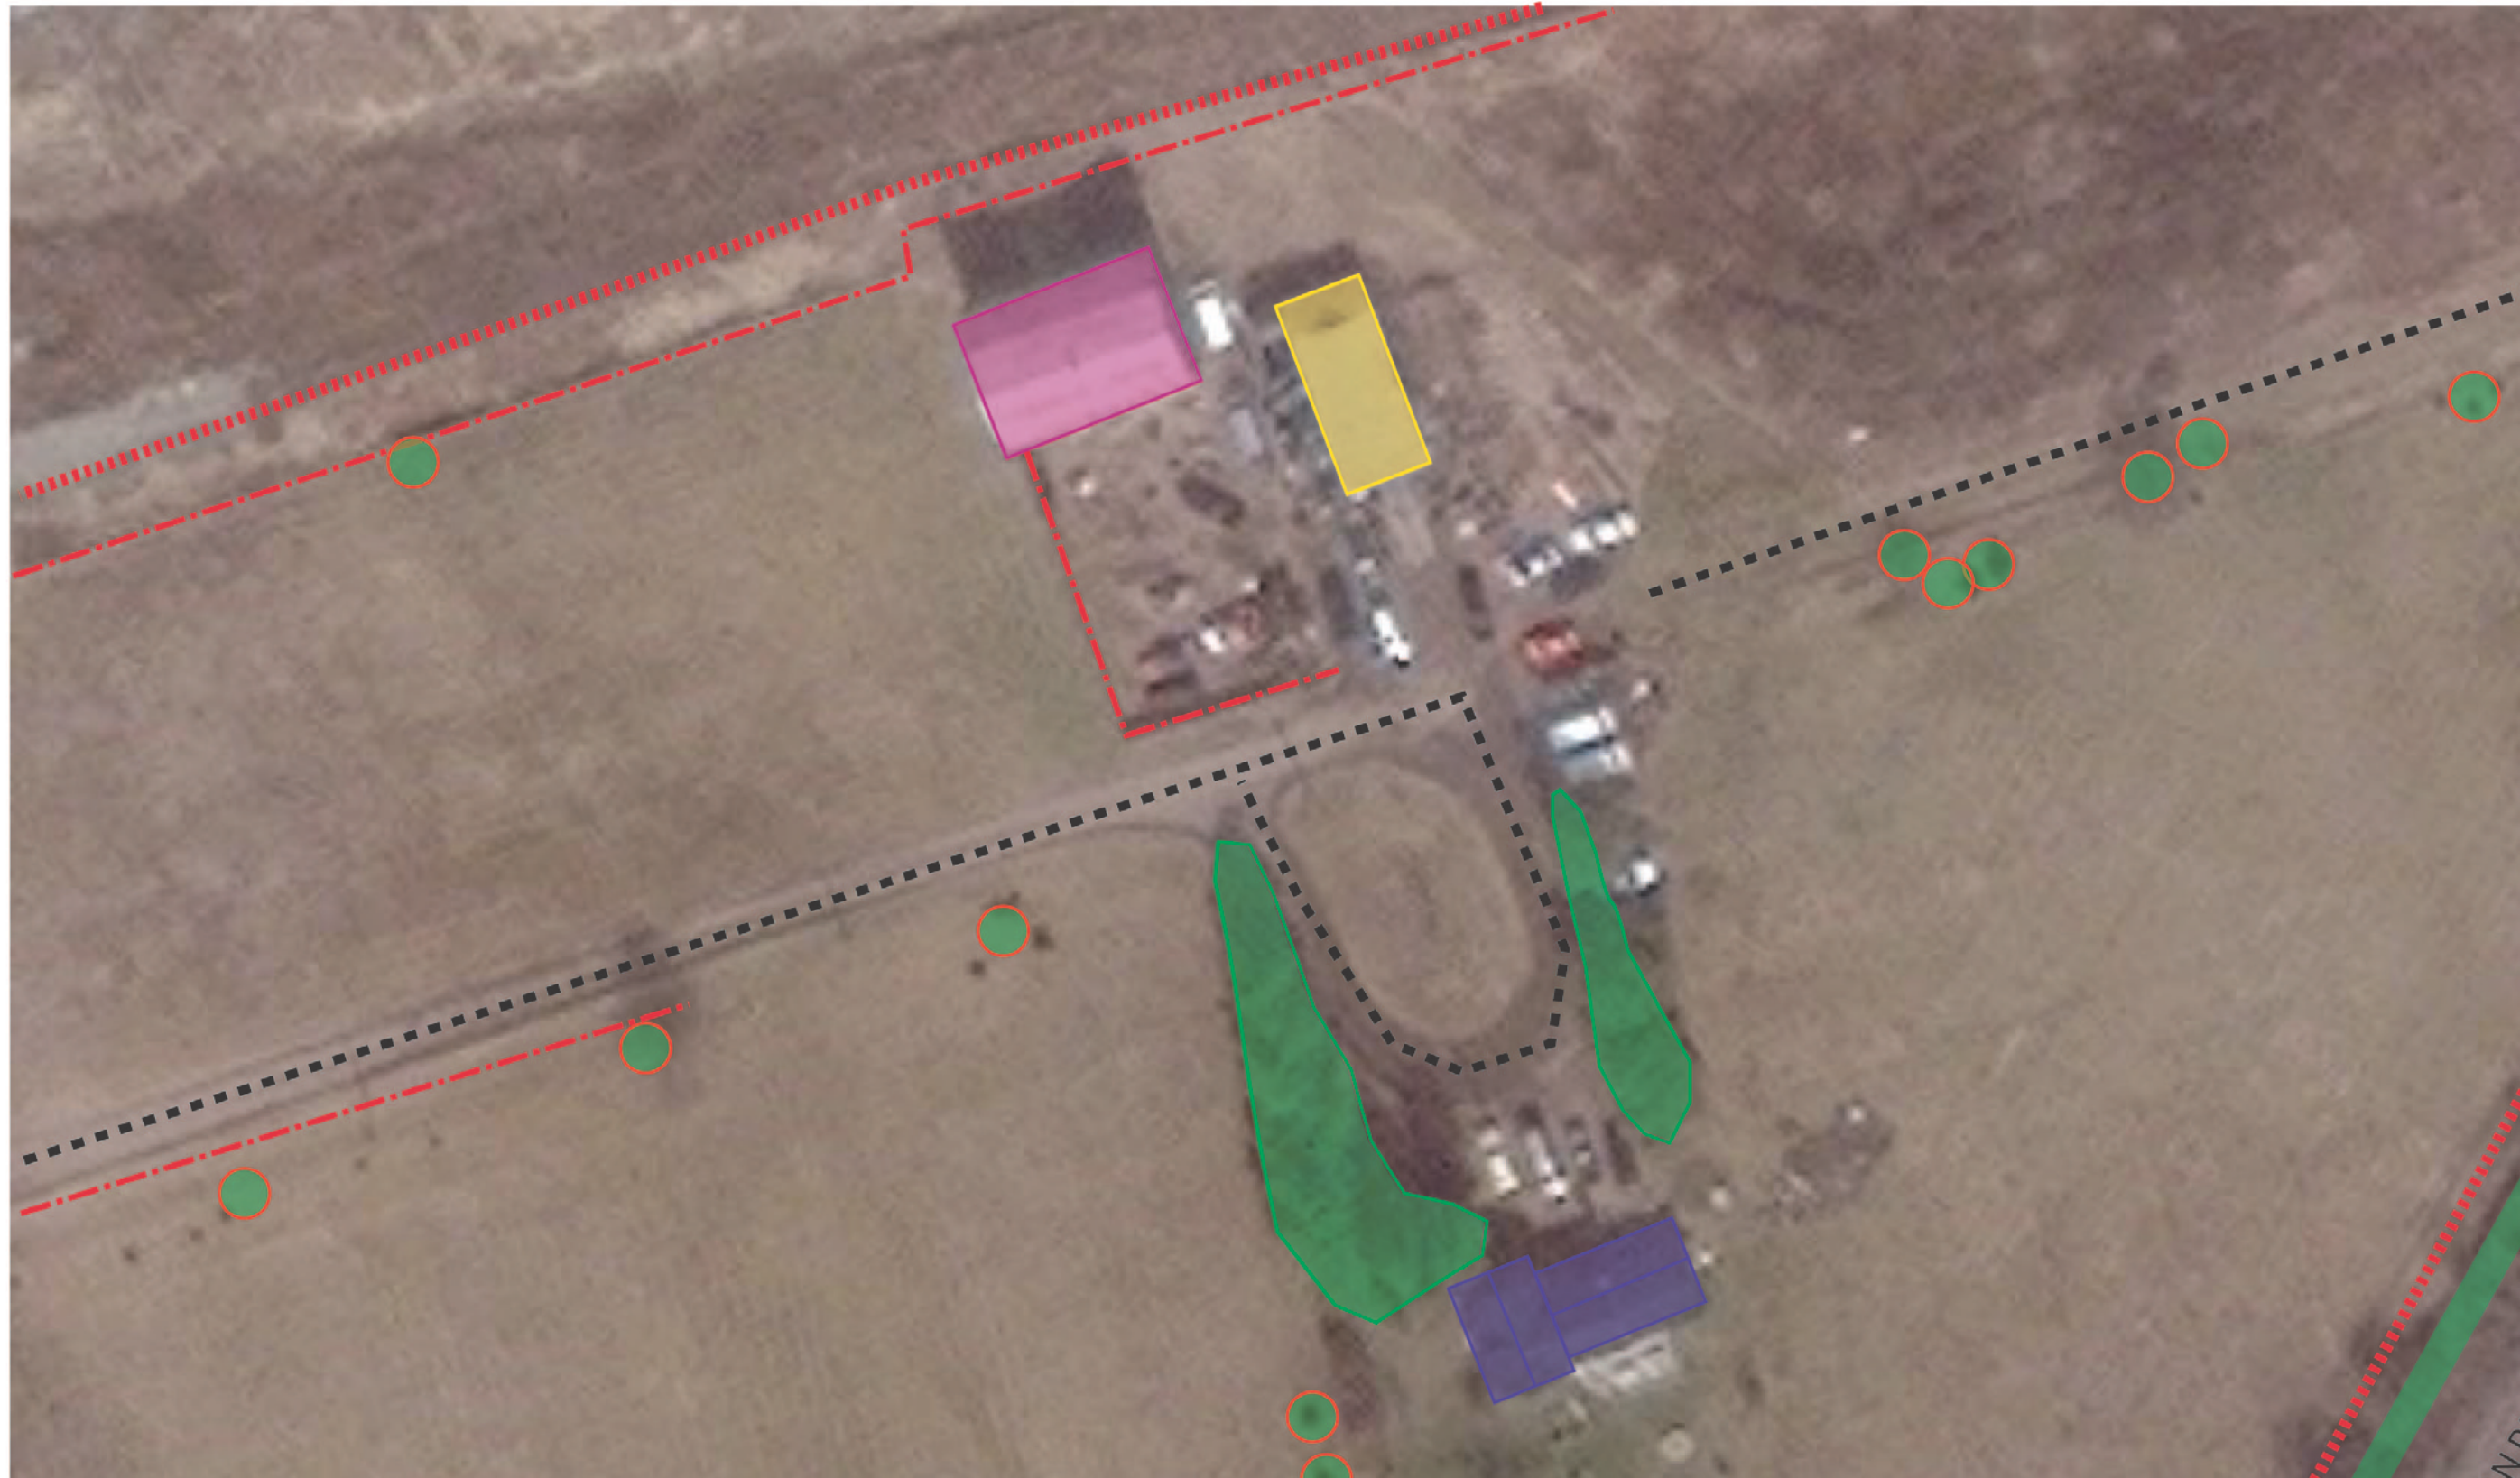
Plate 4: View looking north showing relationship between Reesor Road (far left) and farmstead at 8119 Reesor Road (right).

- Former farm complex set back from the road (Plate 4);
- Wooden fence around the south and west sides of a former work yard south of the barn, now containing spare vehicles and vehicle parts;
- Buildings arranged with farmhouse to the south, outbuildings to the north, a typical arrangement of an Ontario farmstead as the outbuildings also served as a windbreak for the house;
- Intact circulation routes linking the buildings to the road, and the buildings to the former fields to the east of the farm complex; and
- Vegetation on the property includes: decorative plantings along the driveway; trees planted to screen the highway from the property; windbreaks that screen the farmhouse from the road and outbuildings; and trees that have naturally grown along the rail line, effectively screening it from the subject property.

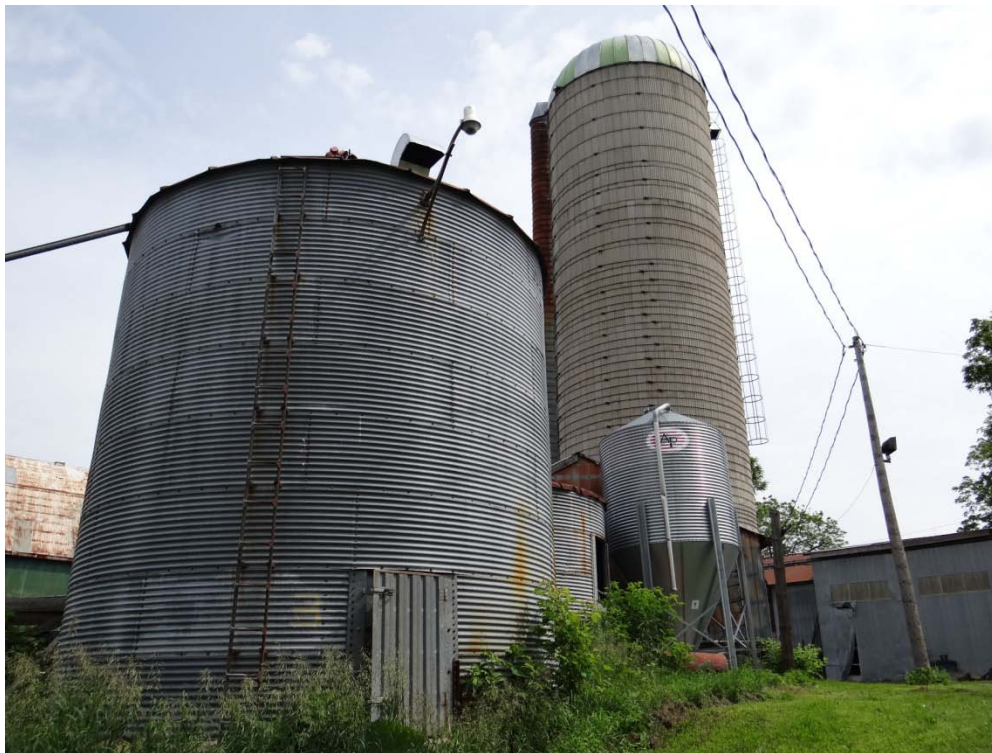
Plate 3: South elevation stave silo and representative modern corrugated metal silo, part of the granary complex at 8042 Reesor Road.

- Expanded late-nineteenth/early twentieth century barn with partial fieldstone foundations;
- Mid-twentieth century granary with corrugated metal silos; and
- Early twentieth-century stave silo.

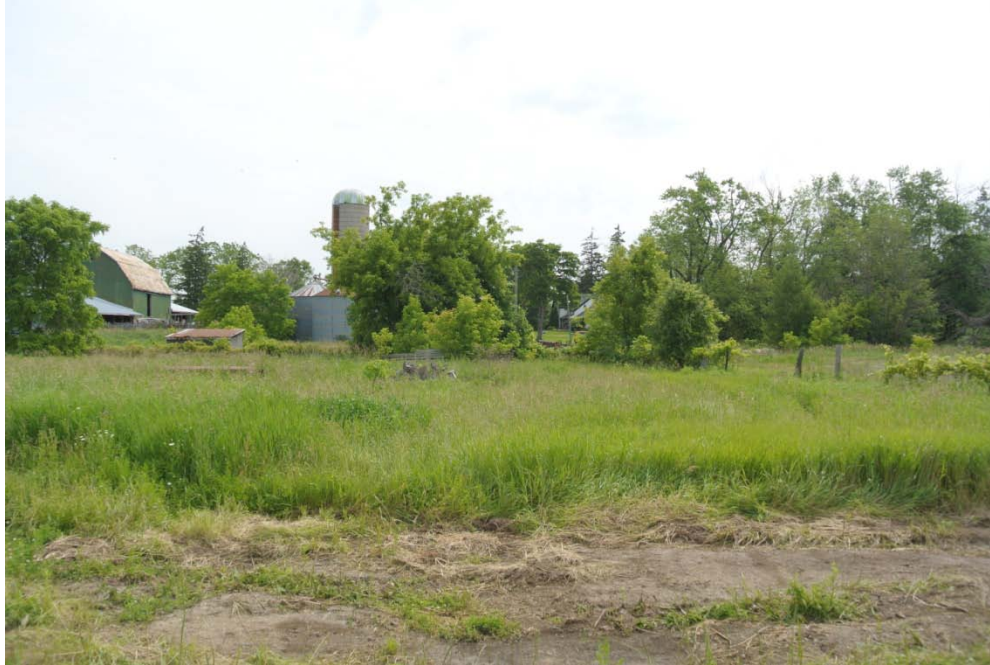
The property at 8042 Reesor Road is located on Part of Lots 7 and 8, Concession 9 within the Township of Markham, Ontario. It is located on the west side of Reesor Road in the City of Markham and features a one-and-a-half-storey frame house, a large barn, granary featuring nine silos, and two outbuildings. The original farm has been disrupted by a few developments, including the construction of a railway line in the 1880s, built diagonally across the original farm and now forming the south limits of the property.

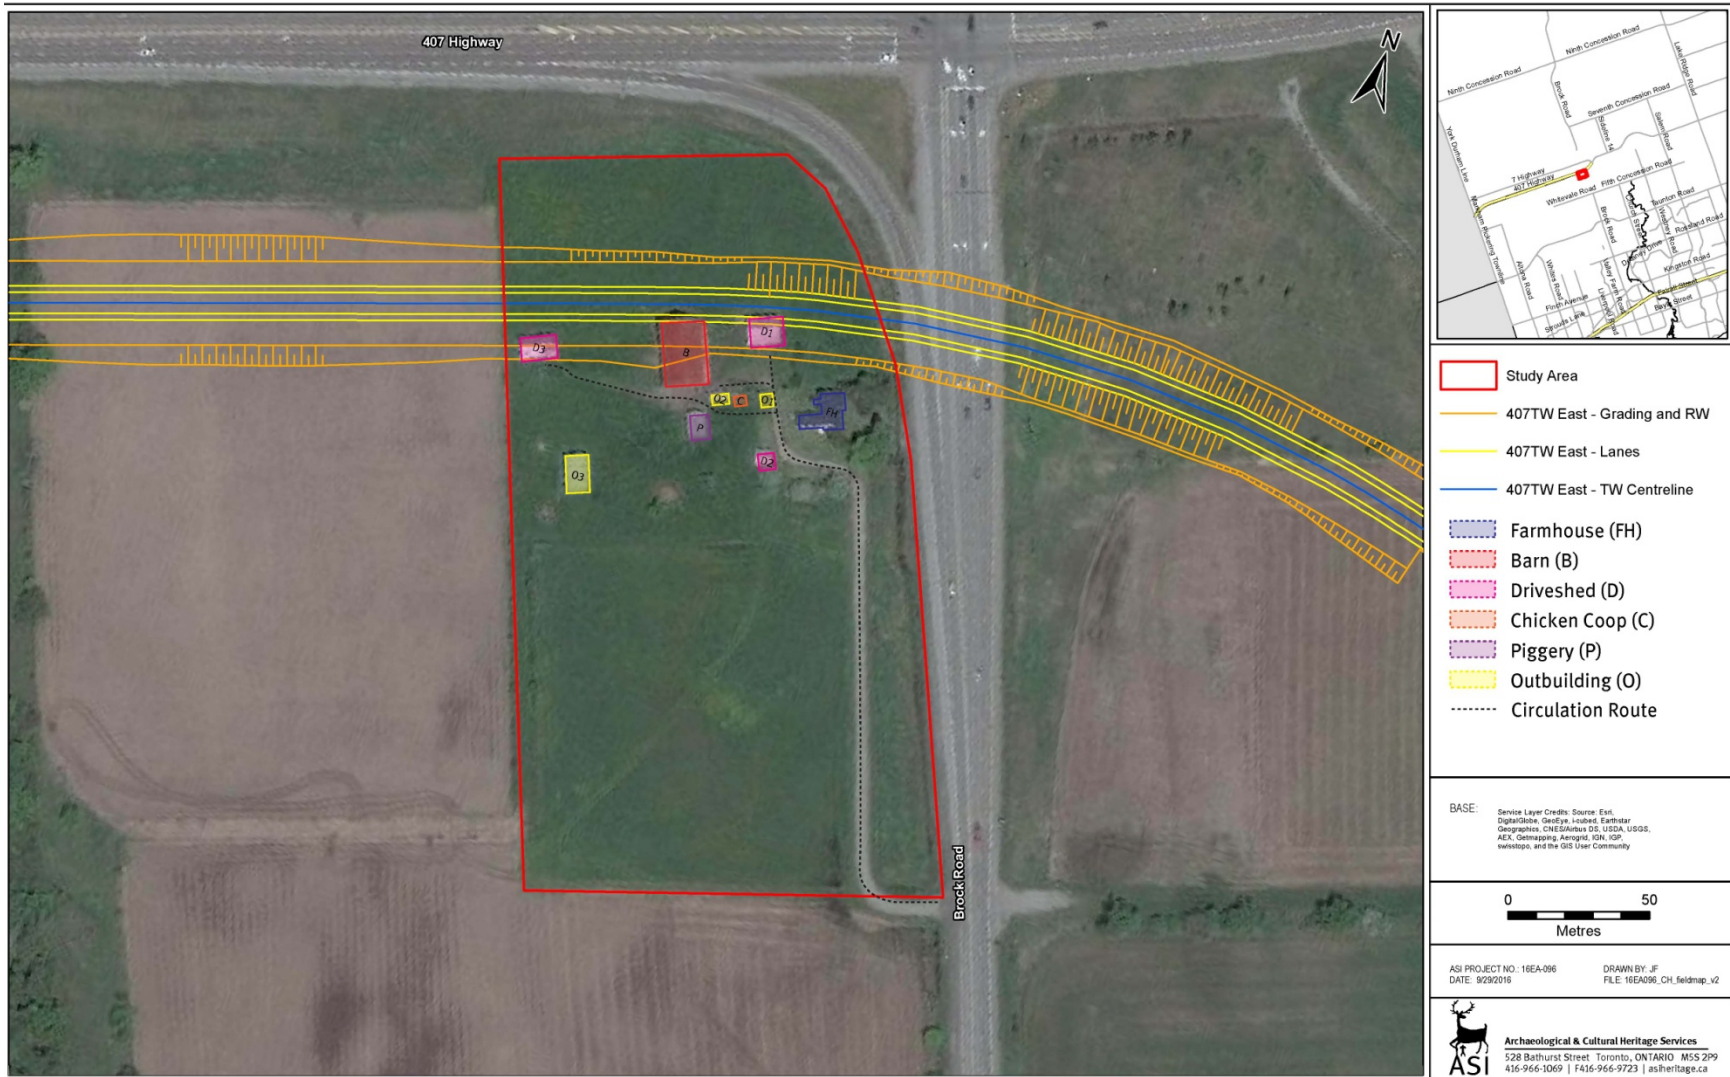
Figure 2: Proposed Design for the 407 Transitway within the study area, with structures and landscape features depicted
