Appendix N: Contamination Report

407 TRANSITWAY - KENNEDY ROAD TO BROCK ROAD MINISTRY OF TRANSPORTATION - CENTRAL REGION

CONTAMINATION OVERVIEW STUDY - FINAL REPORT

Highway 407 Transitway from East of Kennedy Road to East of Brock Road, GWP 13-20003

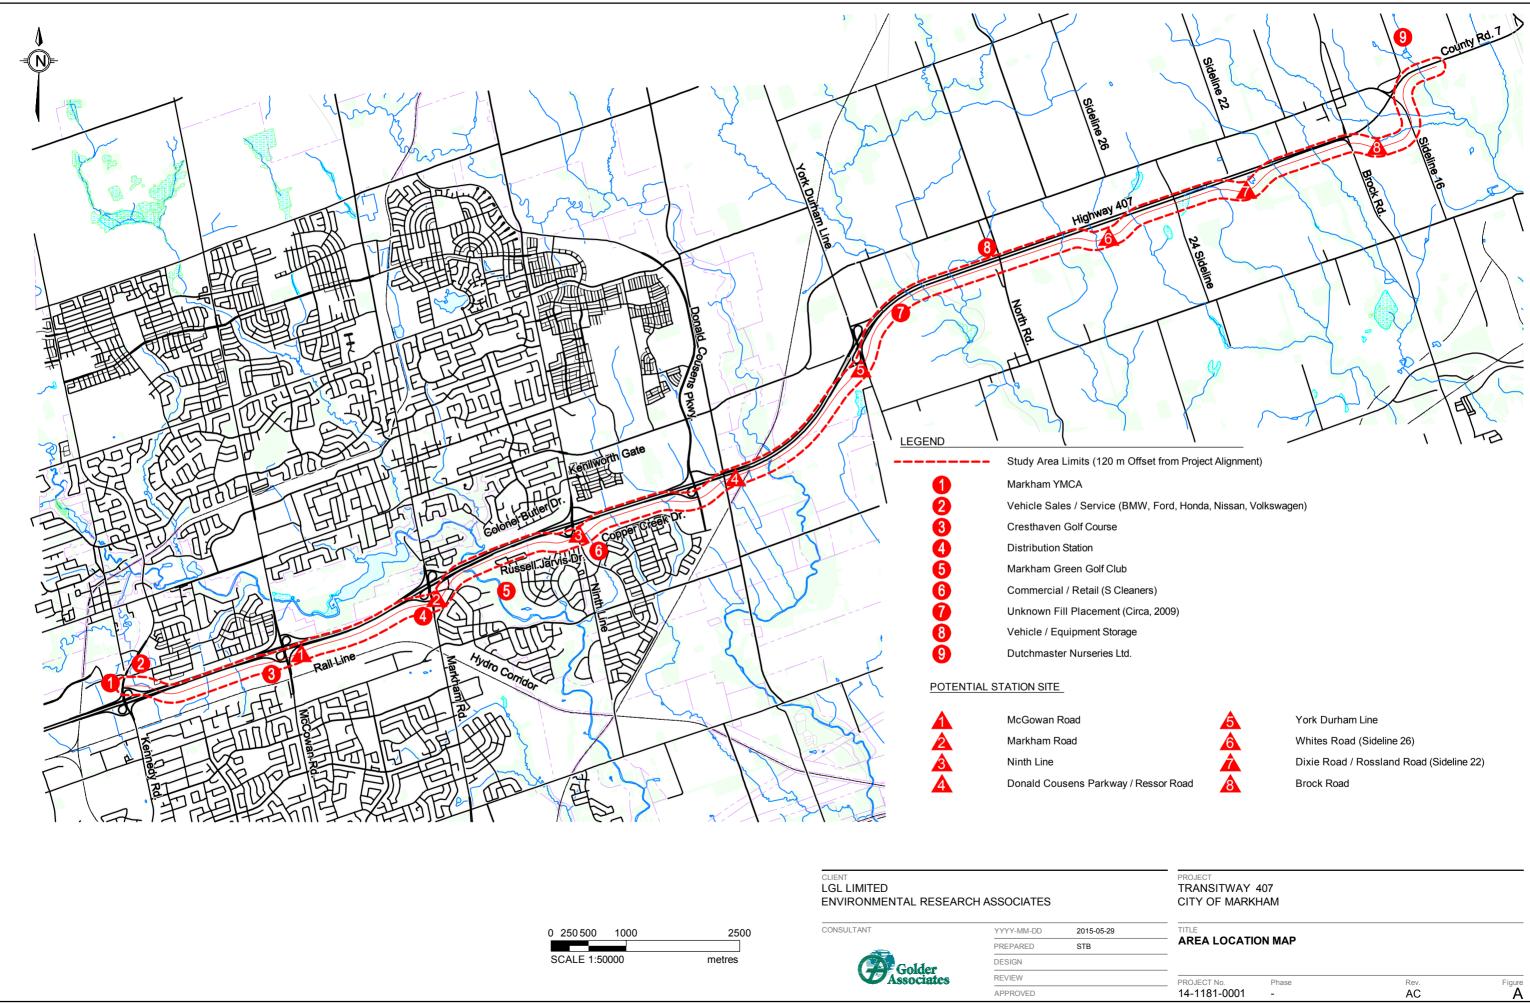
Golder Associates Ltd. ("Golder") was retained by LGL Limited ("LGL") on behalf of Parsons and the Ministry of Transportation ("MTO") to carry out a Contamination Overview Study relating to contaminated lands and waste management for an 18 km section of the Transitway from east of Kennedy Road to east of Brock Road and eight potential stations including McCowan Road, Markham Road, 9th Line, Donald Cousens Pkwy/Reesor Road, York Durham Line, Whites Road (Sideline 26), Dixie Road/Rossland Road (Sideline 22) and Brock Road, in the cities of Markham and Pickering, Ontario (i.e., the "study area"). The study area, preferred alignment and limits are shown on Figure A (Appendix A).

- Level 2: four properties (Properties 1, 2, 4, and 7, Figure A) require further assessment to determine whether subsurface investigations would be warranted (i.e., a Phase I ESA is recommended).
- Level 3: five properties (Properties 3, 5, 6, 8, and 9, Figure A) require subsurface environmental investigation to determine whether soil and/or groundwater impacts exist at the properties.
