407 TRANSITWAY - KENNEDY ROAD TO BROCK ROAD

**CULTURAL HERITAGE EVALUATION REPORT:
BUILT HERITAGE RESOURCES AND CULTURAL HERITAGE LANDSCAPES**

**8119 REESOR ROAD
LOT 8, CONCESSION 10
CITY OF MARKHAM, HISTORIC TOWNSHIP OF MARKHAM
REGIONAL MUNICIPALITY OF YORK**

ASI File: 15EA-078

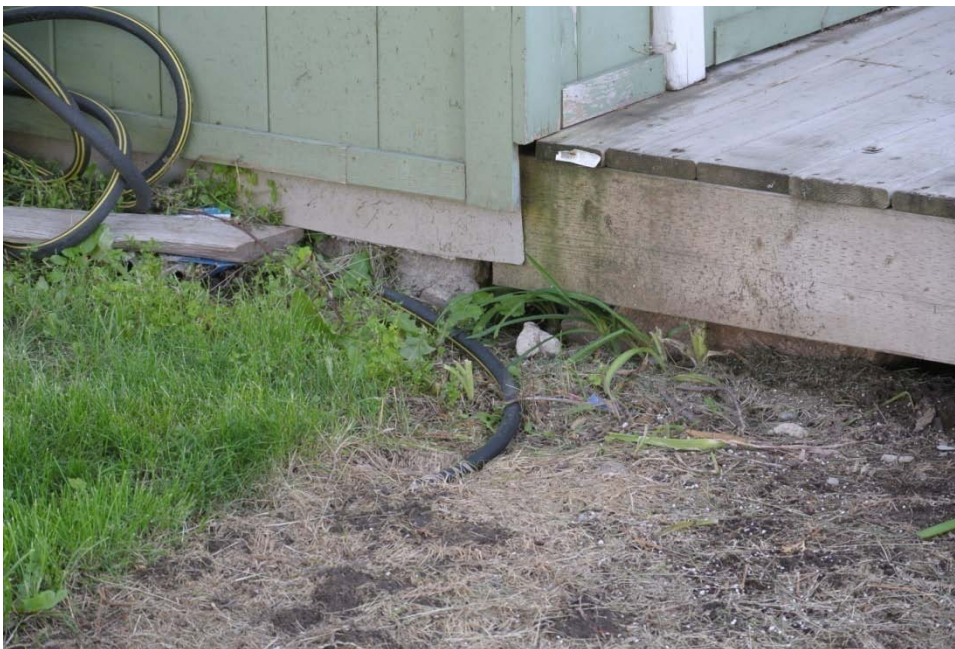
Plate 6: Detail of stone foundations under the northwest corner of the house.

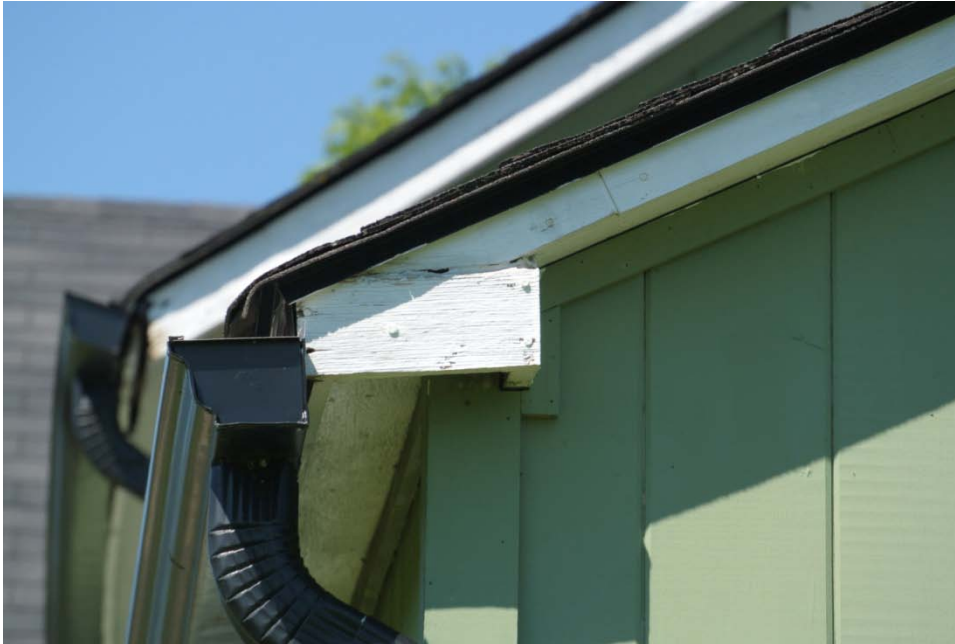
Plate 7: Detail of vertical wooden clapboarding and wooden fascia, soffit and return eaves.

concrete footings were poured into place sometime during the early twentieth century. Further, the house exterior is uniformly clad with vertical, tongue-and-groove wooden boards. This cladding may date to the nineteenth century, when the rear one-storey extension was added to the dwelling. According to the property file held at the City of Markham, the former Insulbrick siding was replaced in c.2006. Repairs to the verandah were also undertaken at this time, which saw the replacement of the former concrete deck with the current wooden deck, and the original posts. The existing wood structure including the roof and brackets were retained and repaired where necessary.

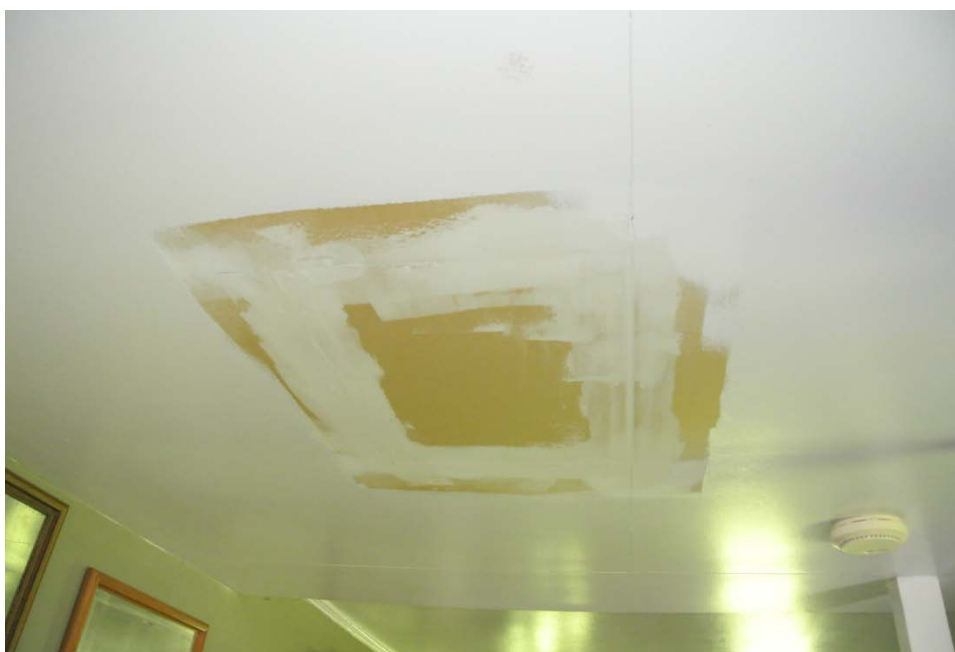
Plate 24: Detail showing patchwork from a former leakage problem.

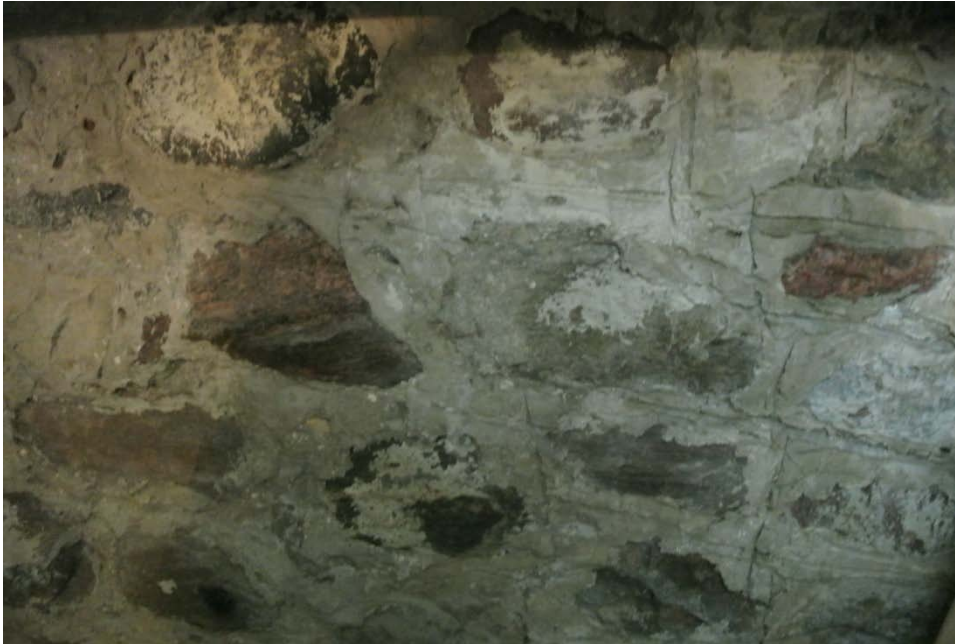
Plate 43: Detail of stone foundation walls.

The basement with exposed stone foundations, dirt floor and wooden framing is situated underneath the middle, one-and-a-half storey ‘tail’ of the dwelling (Plates 42 – 49). It likely served as a root cellar originally. The foundations are rough-fieldstone construction. As mentioned above, it was difficult to investigate the basement any further due to flooding and usage as a storage room. Further, visibility of the wooden framing of the floor above was obstructed by insulation and utilities (furnace and associated duct

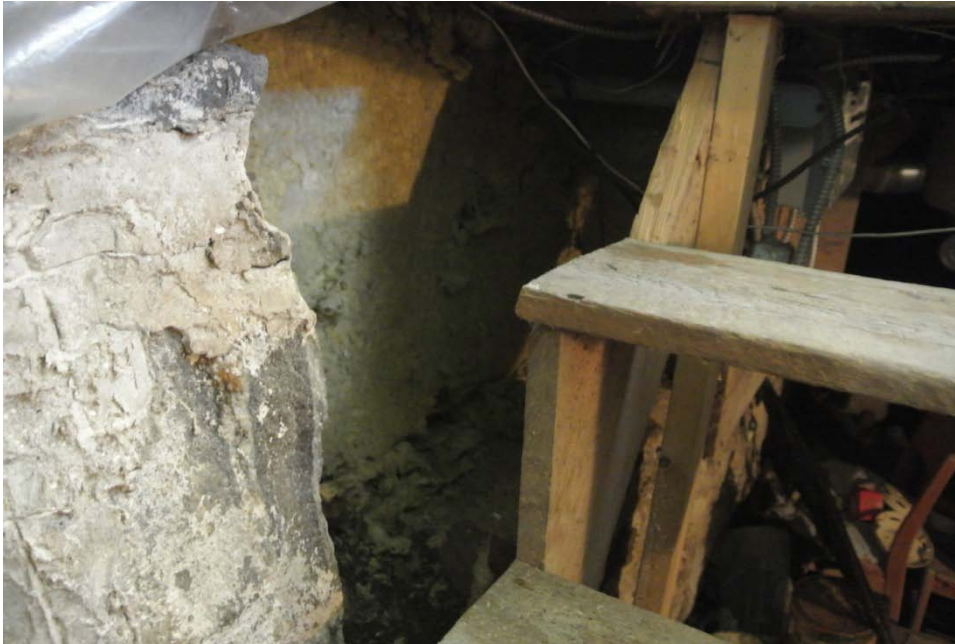
Plate 49: Detail of gap in the foundations on the north wall.

work, and water heaters). One section of the subfloor above was visible, and it appears that the original wood boards were replaced, likely during kitchen renovations. A gap in the foundations along the north wall was also observed. This may have one time served as a window, or coal chute.

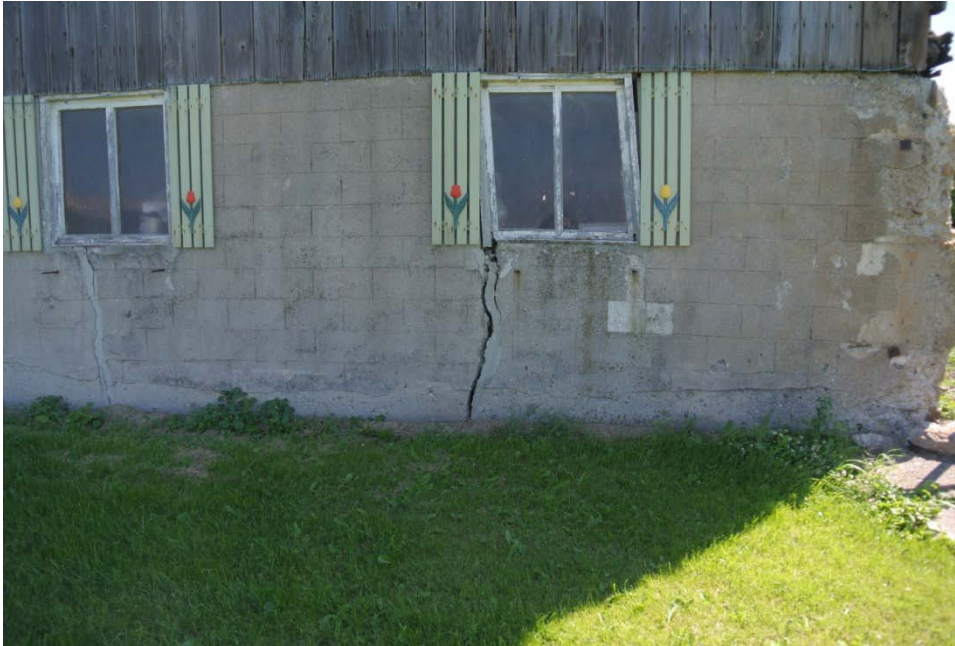
Plate 55: Detail of concrete foundations, west elevation. Note the incised lines in the concrete.

There are two outbuildings at 8119 Reesor Road (Plate 50). The first is a large c.1890s gambrel roof barn (Plates 51 – 60) with rectangular footprint, wooden tongue-and-groove board cladding, poured concrete foundations which have been incised to appear as block foundations, and a ramp to the threshing floor of the barn on the north side. The roof is covered with metal sheeting. Access to former fields north of the barn has been cut off by the Highway 407 alignment. The lower part of the barn is currently used for storage of vehicles and vehicle parts, while the upper part is unused. The timber framing is sawn and appears to date to the early twentieth century.

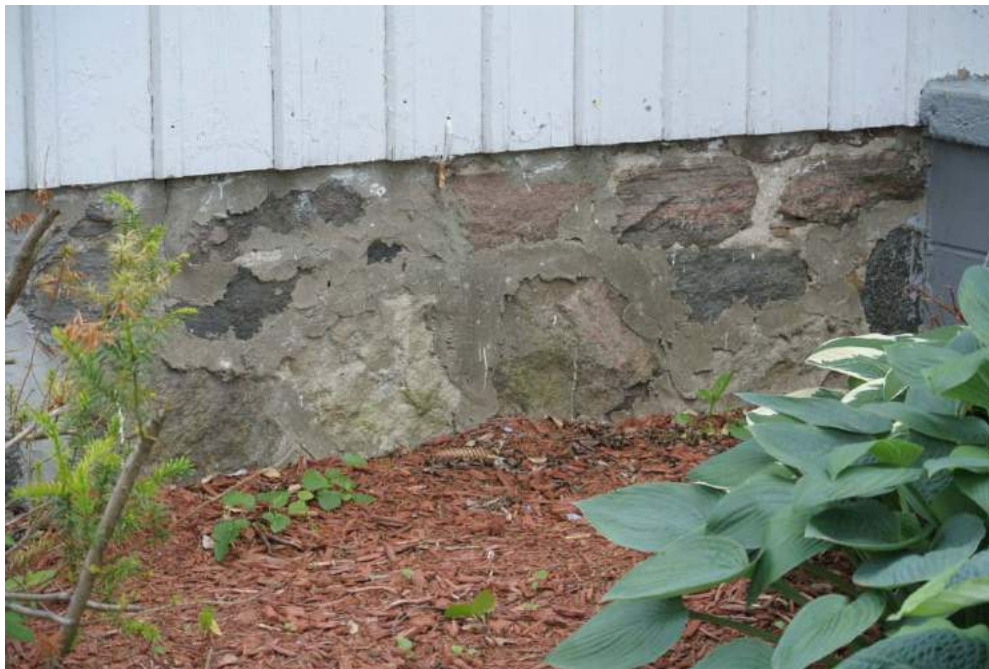
Plate 10: Detail of fieldstone foundations.

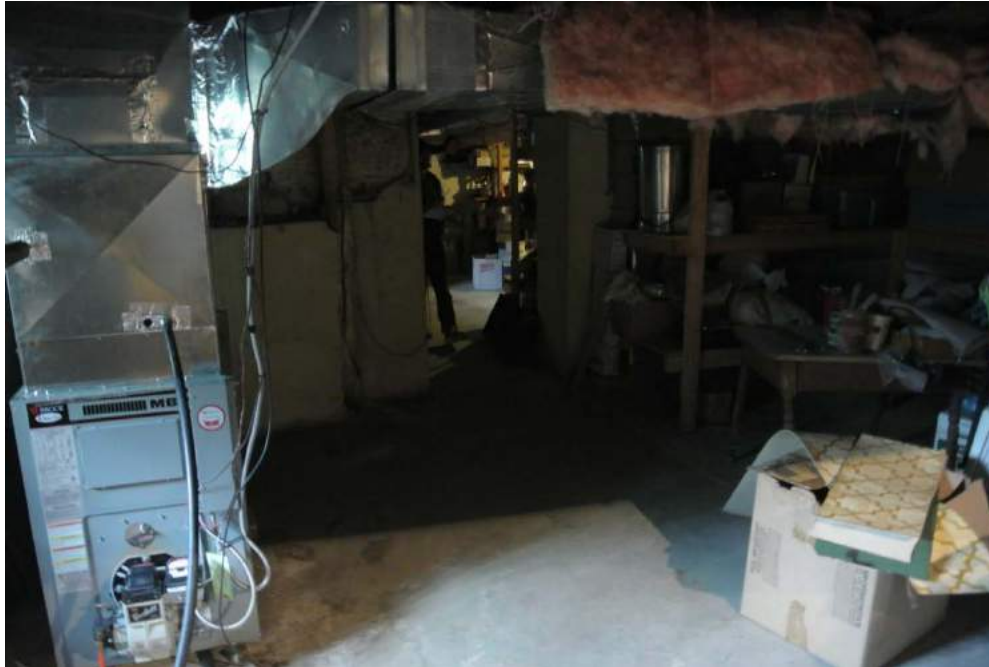
Plate 53: View of the basement of the original structure. Note the poured concrete floor.

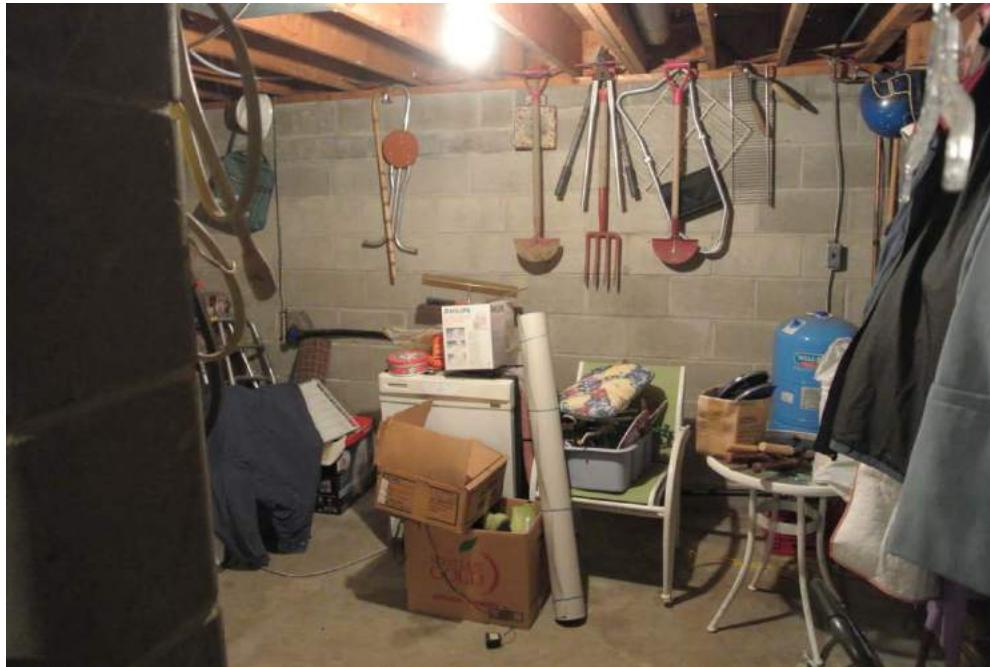
Plate 57: View of basement of modern addition. Note the concrete block foundation, modern cut beams and joists, and poured concrete floor.

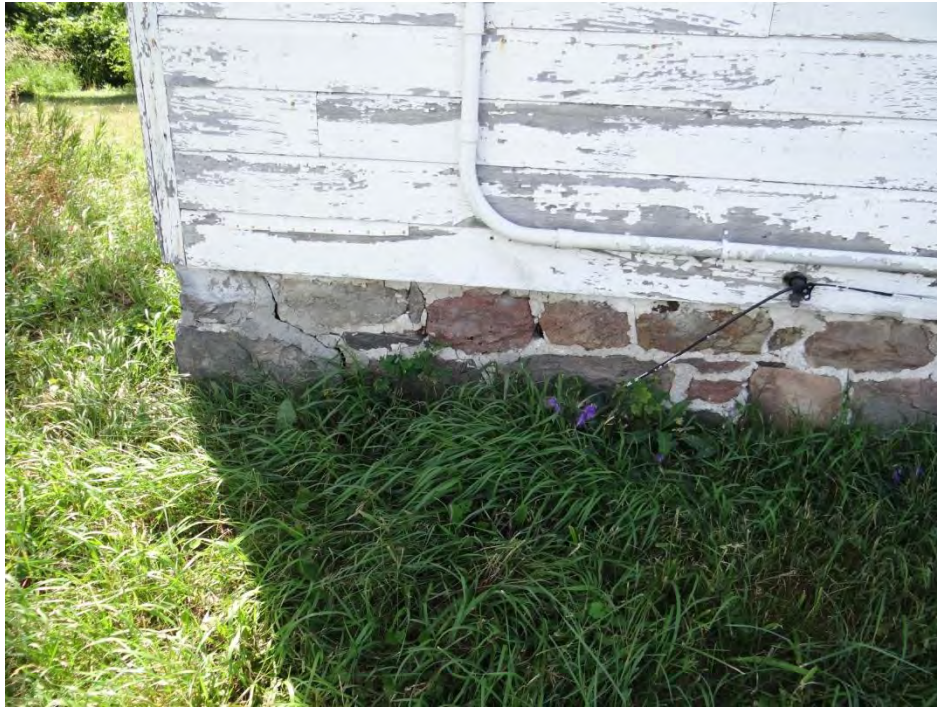
Plate 5: Detail of the stone foundation (northeast corner).

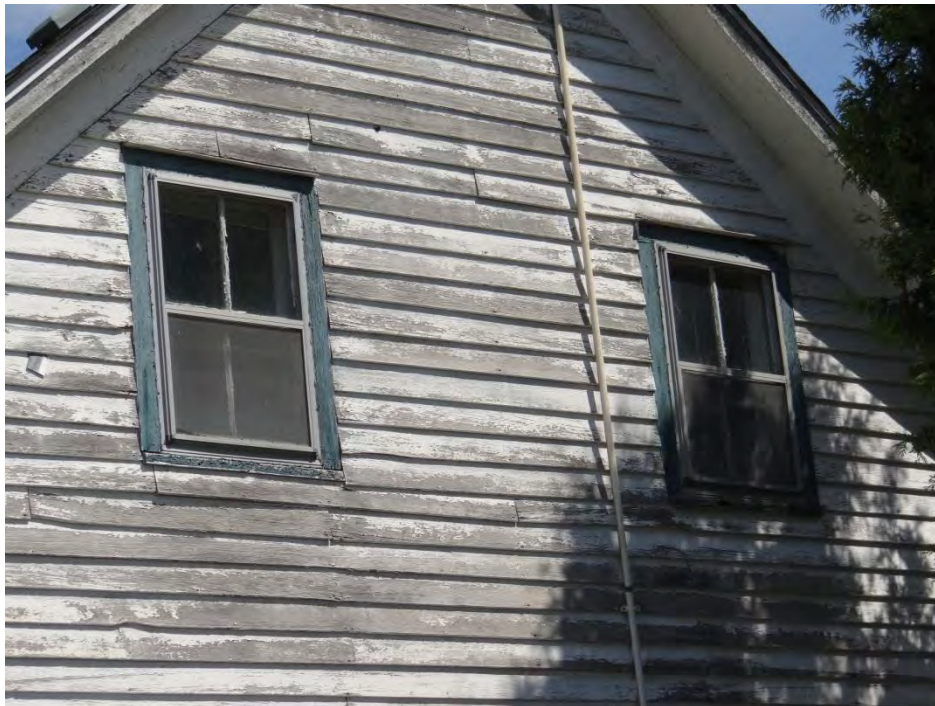
Plate 26: Two-over-two sash windows located in the original south section of the house (south elevation). The original wood storm covers have been replaced with aluminum frame covers.

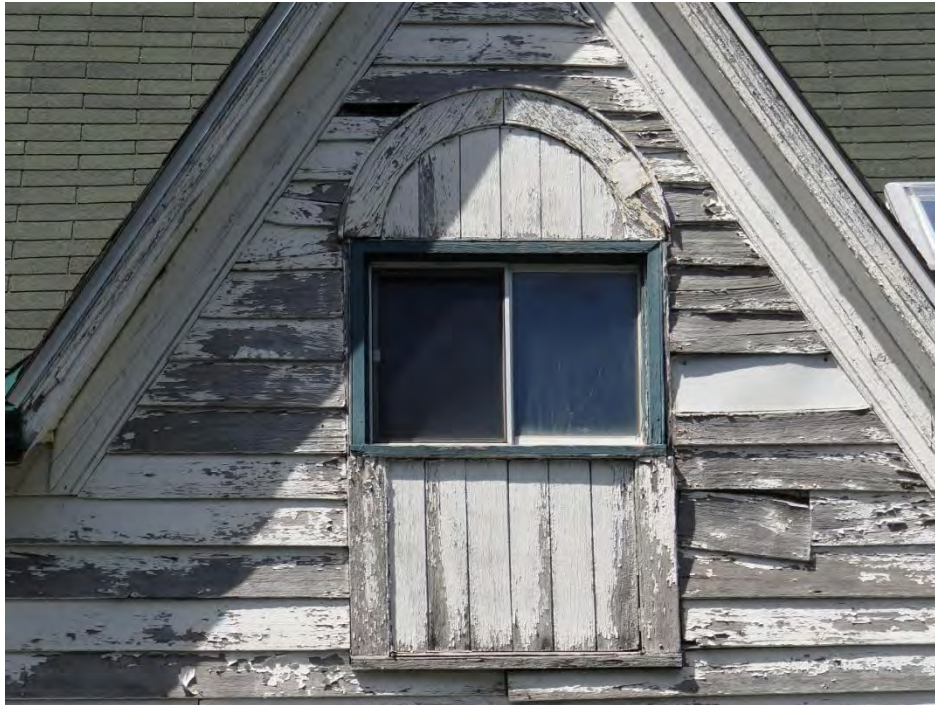
Plate 27: Semi-circular window opening that has been filled and replaced with a modern window.

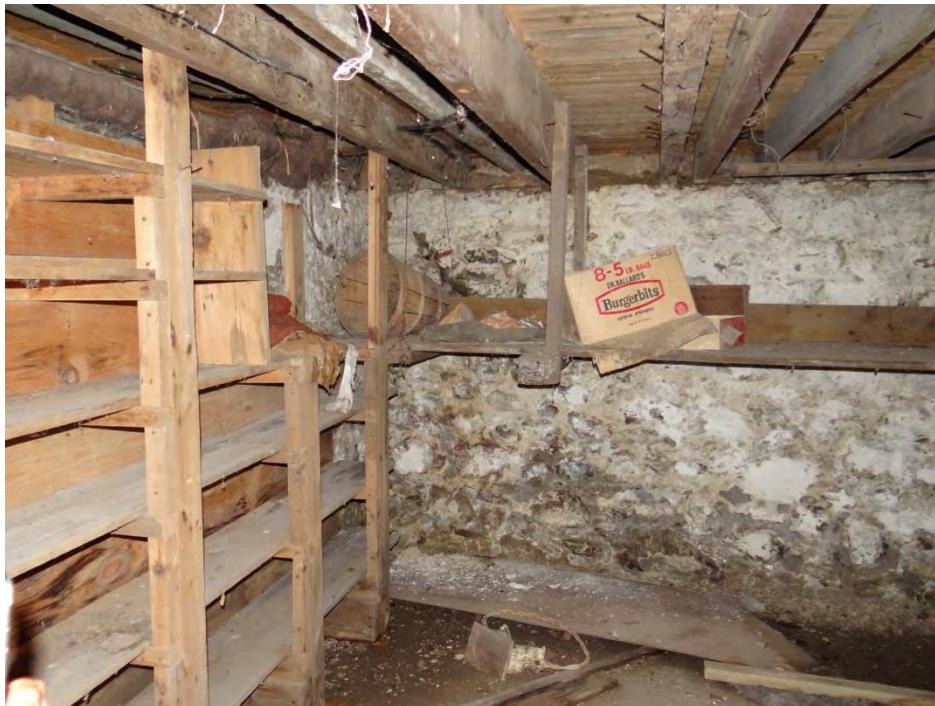
Plate 85: The basement under the original south section of the house. Note the stone foundations, dirt floor, and relatively new/replaced subfloor.

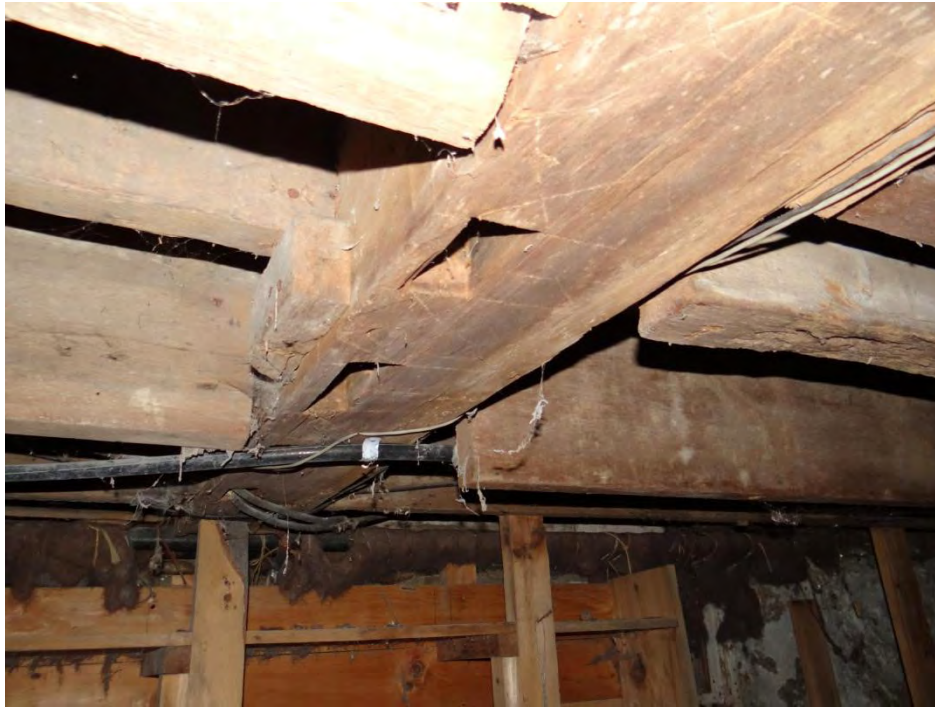
Plate 86: The summer beam in the basement (original south section). Note that the summer beam is hand hewn but that some of the cross beams appear to be newer/replaced.

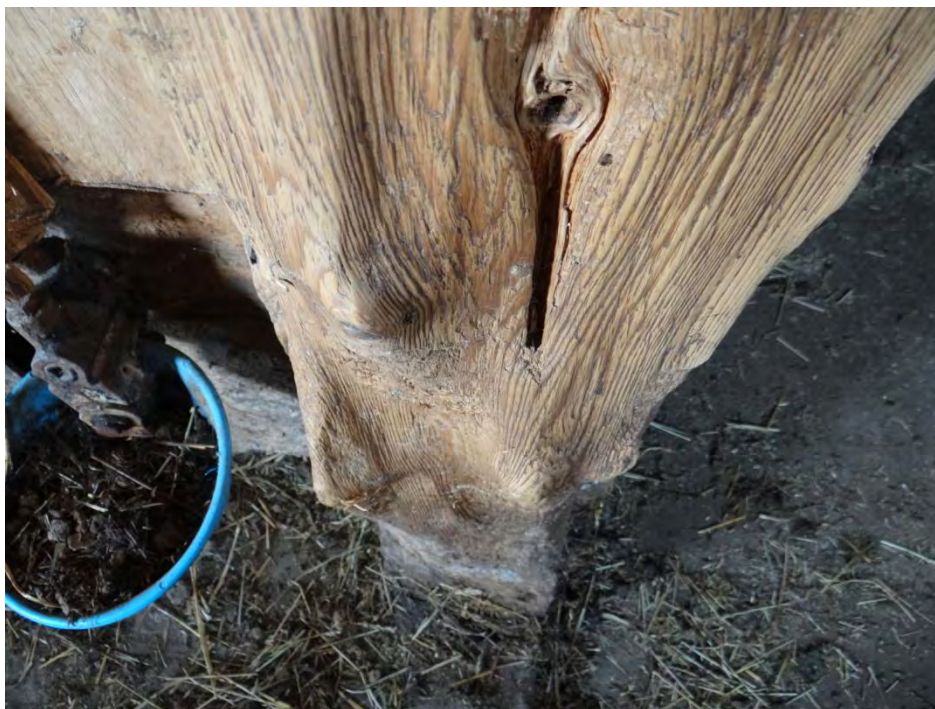
Plate 96: A beam in the lower level of the barn. The contours of the wood are pronounced due to heavy wear from livestock.

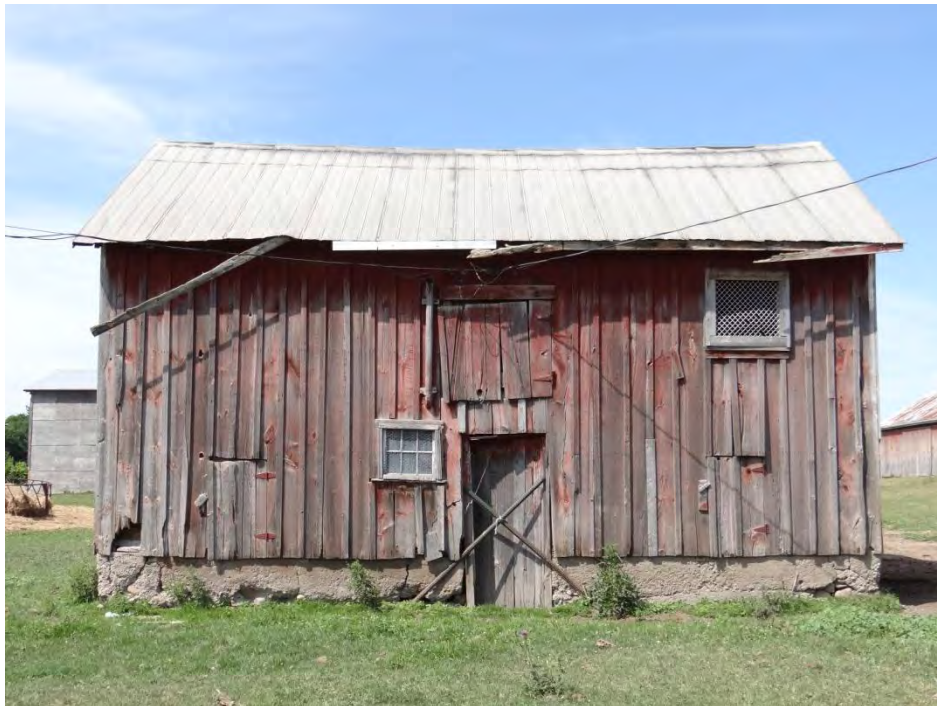
Plate 106: East elevation of the piggery (P). Note the board-and-batten siding and coarse concrete foundations.

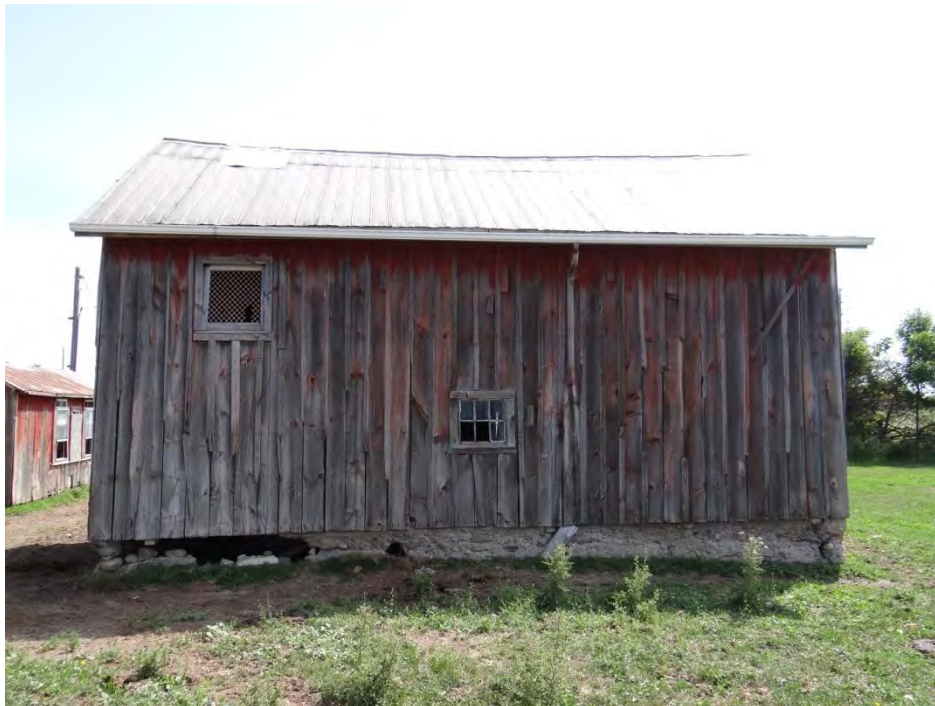
Plate 108: West elevation of the piggery (P). Note the crumbling foundation at the lower left base.
